Surface Water Improvement in Silver Bow Creek AsDis during Base Flow Conditions at SS-07

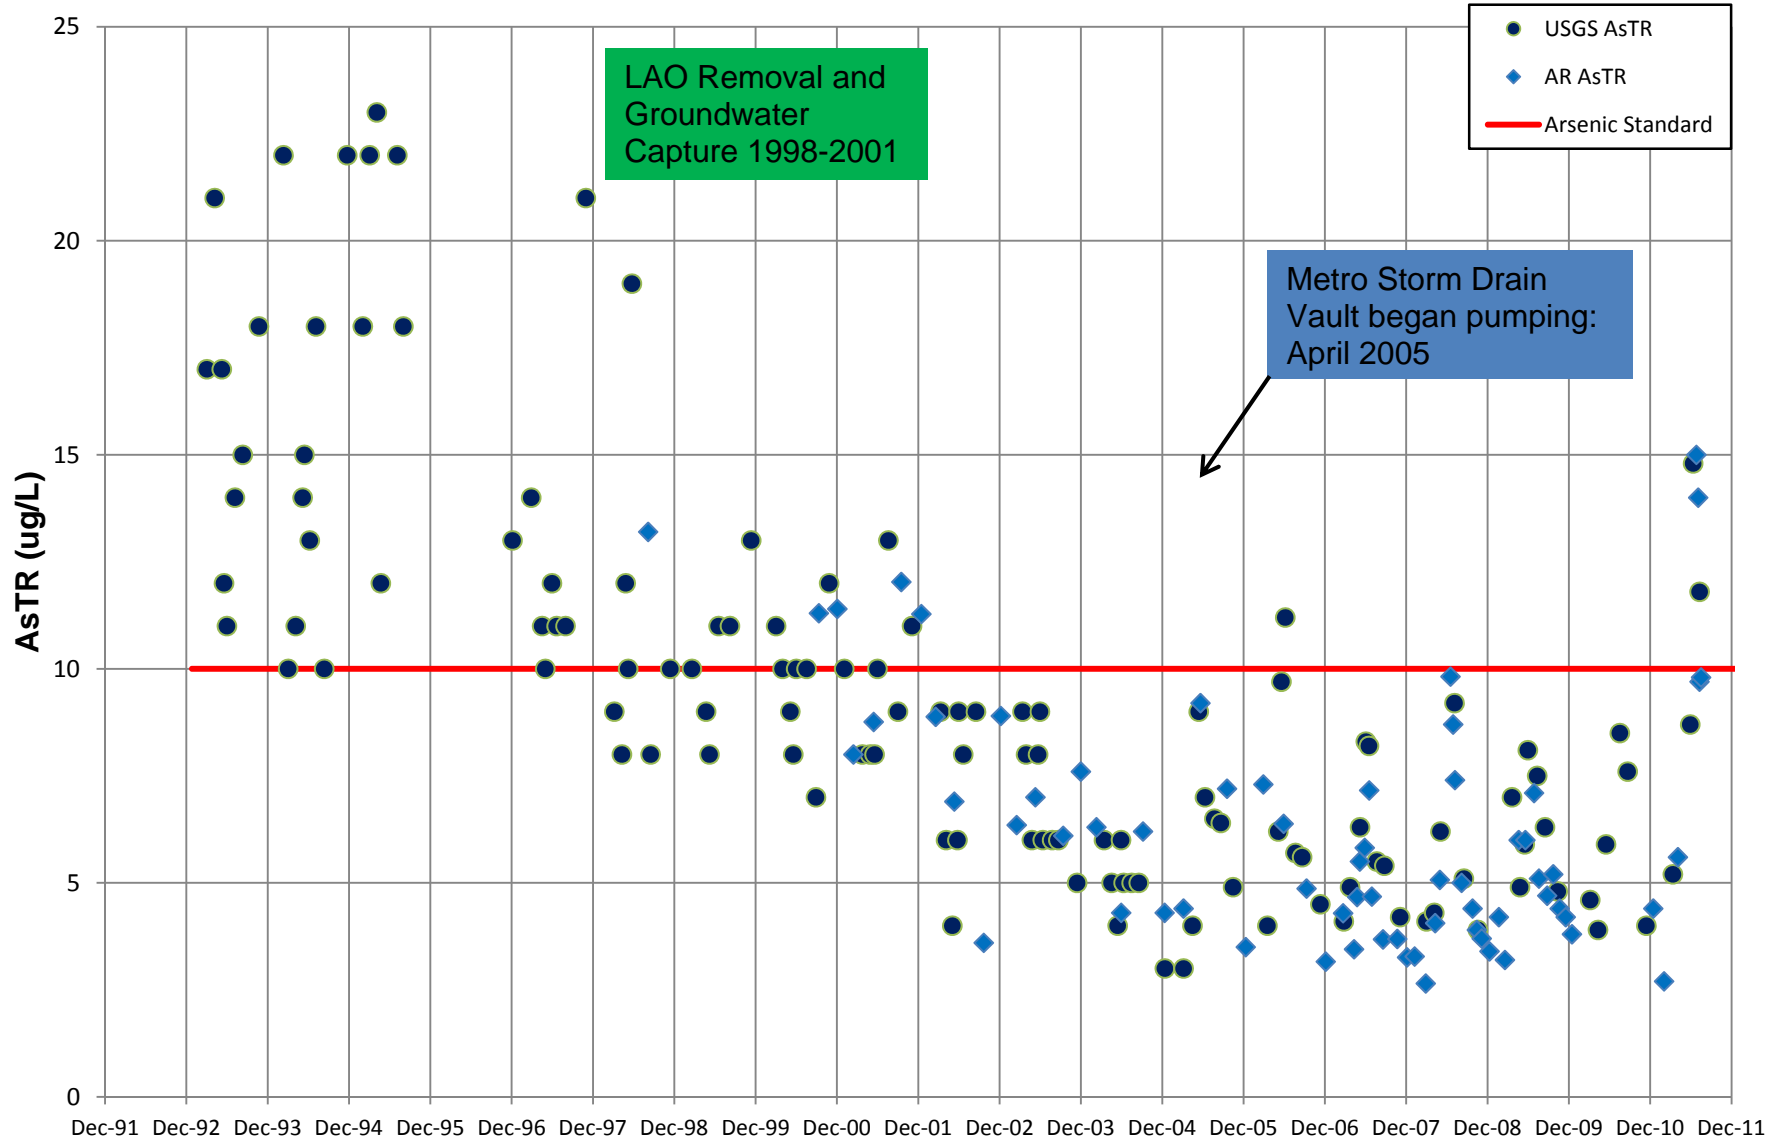
Surface Water Improvement in Silver Bow Creek AsTR during Base Flow Conditions at SS-07 No Outliers

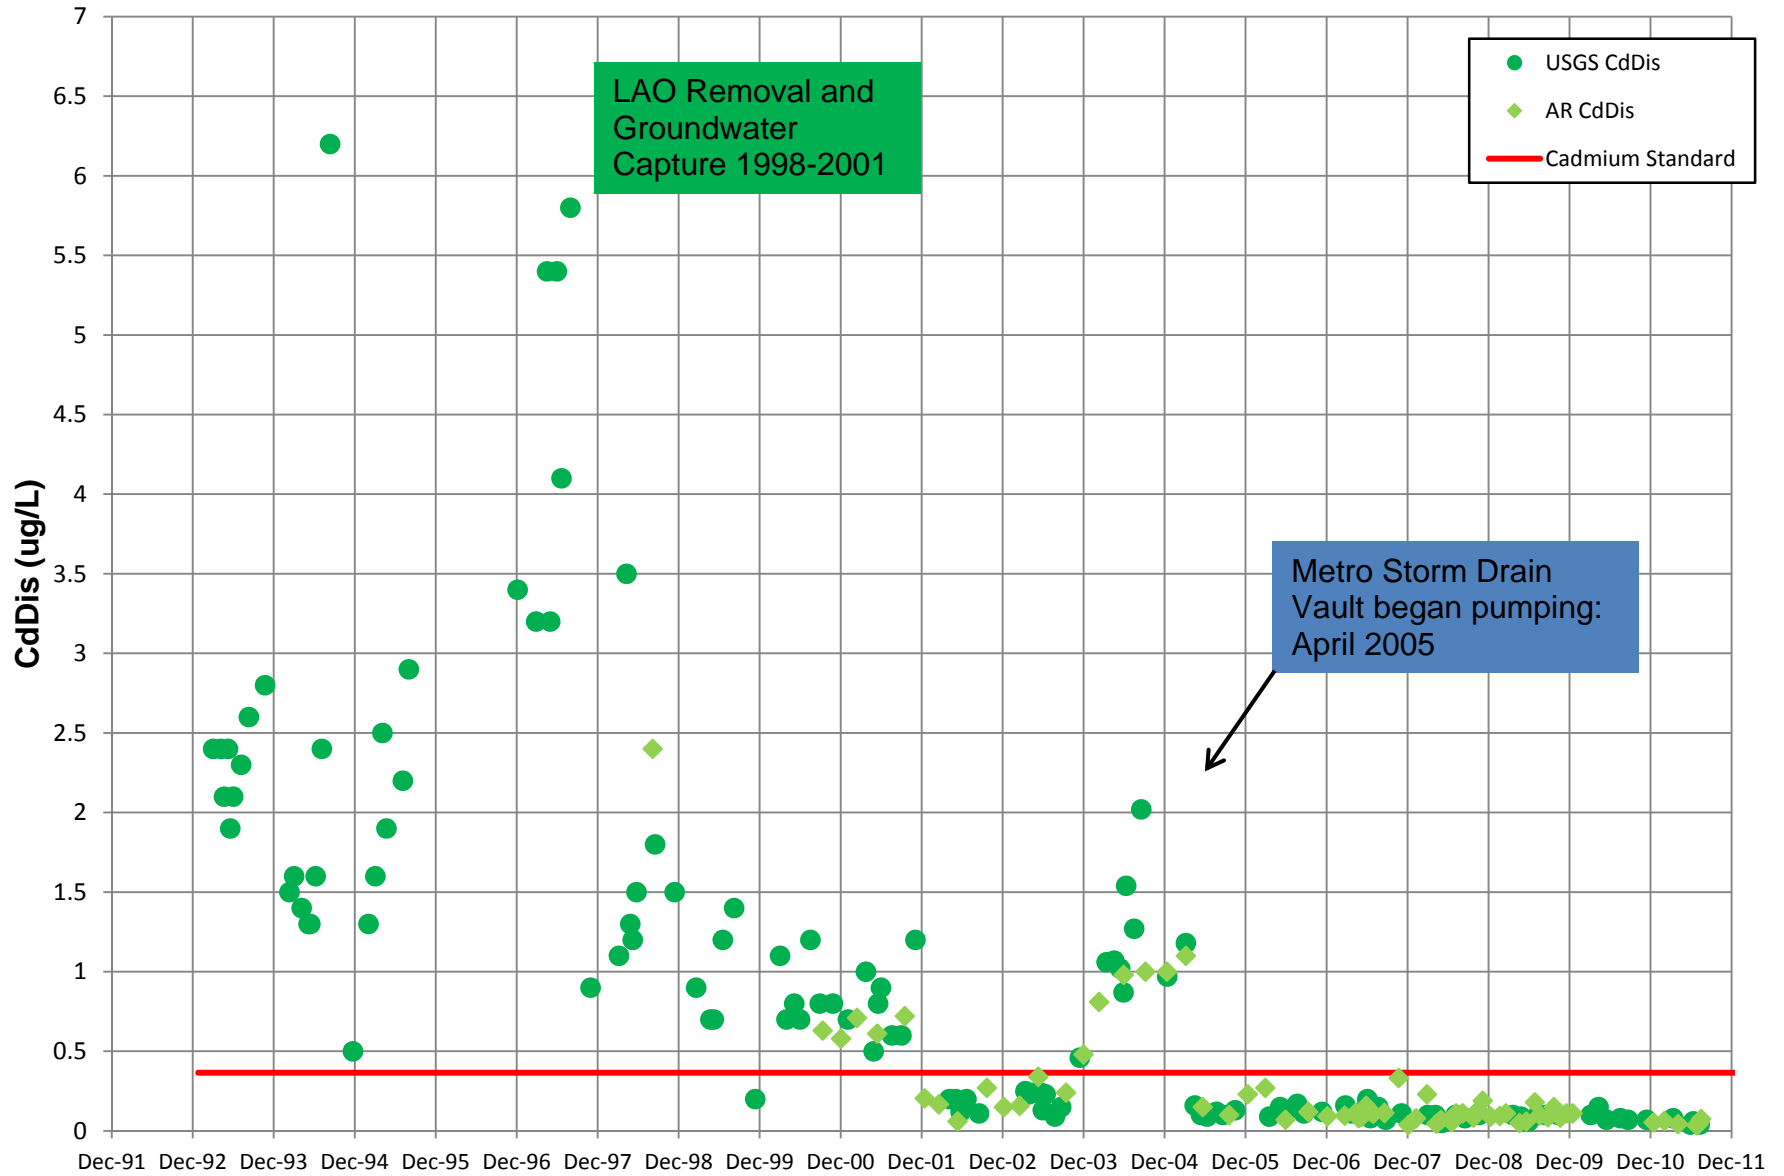
Surface Water Improvement in Silver Bow Creek CdDis during Base Flow Conditions at SS-07

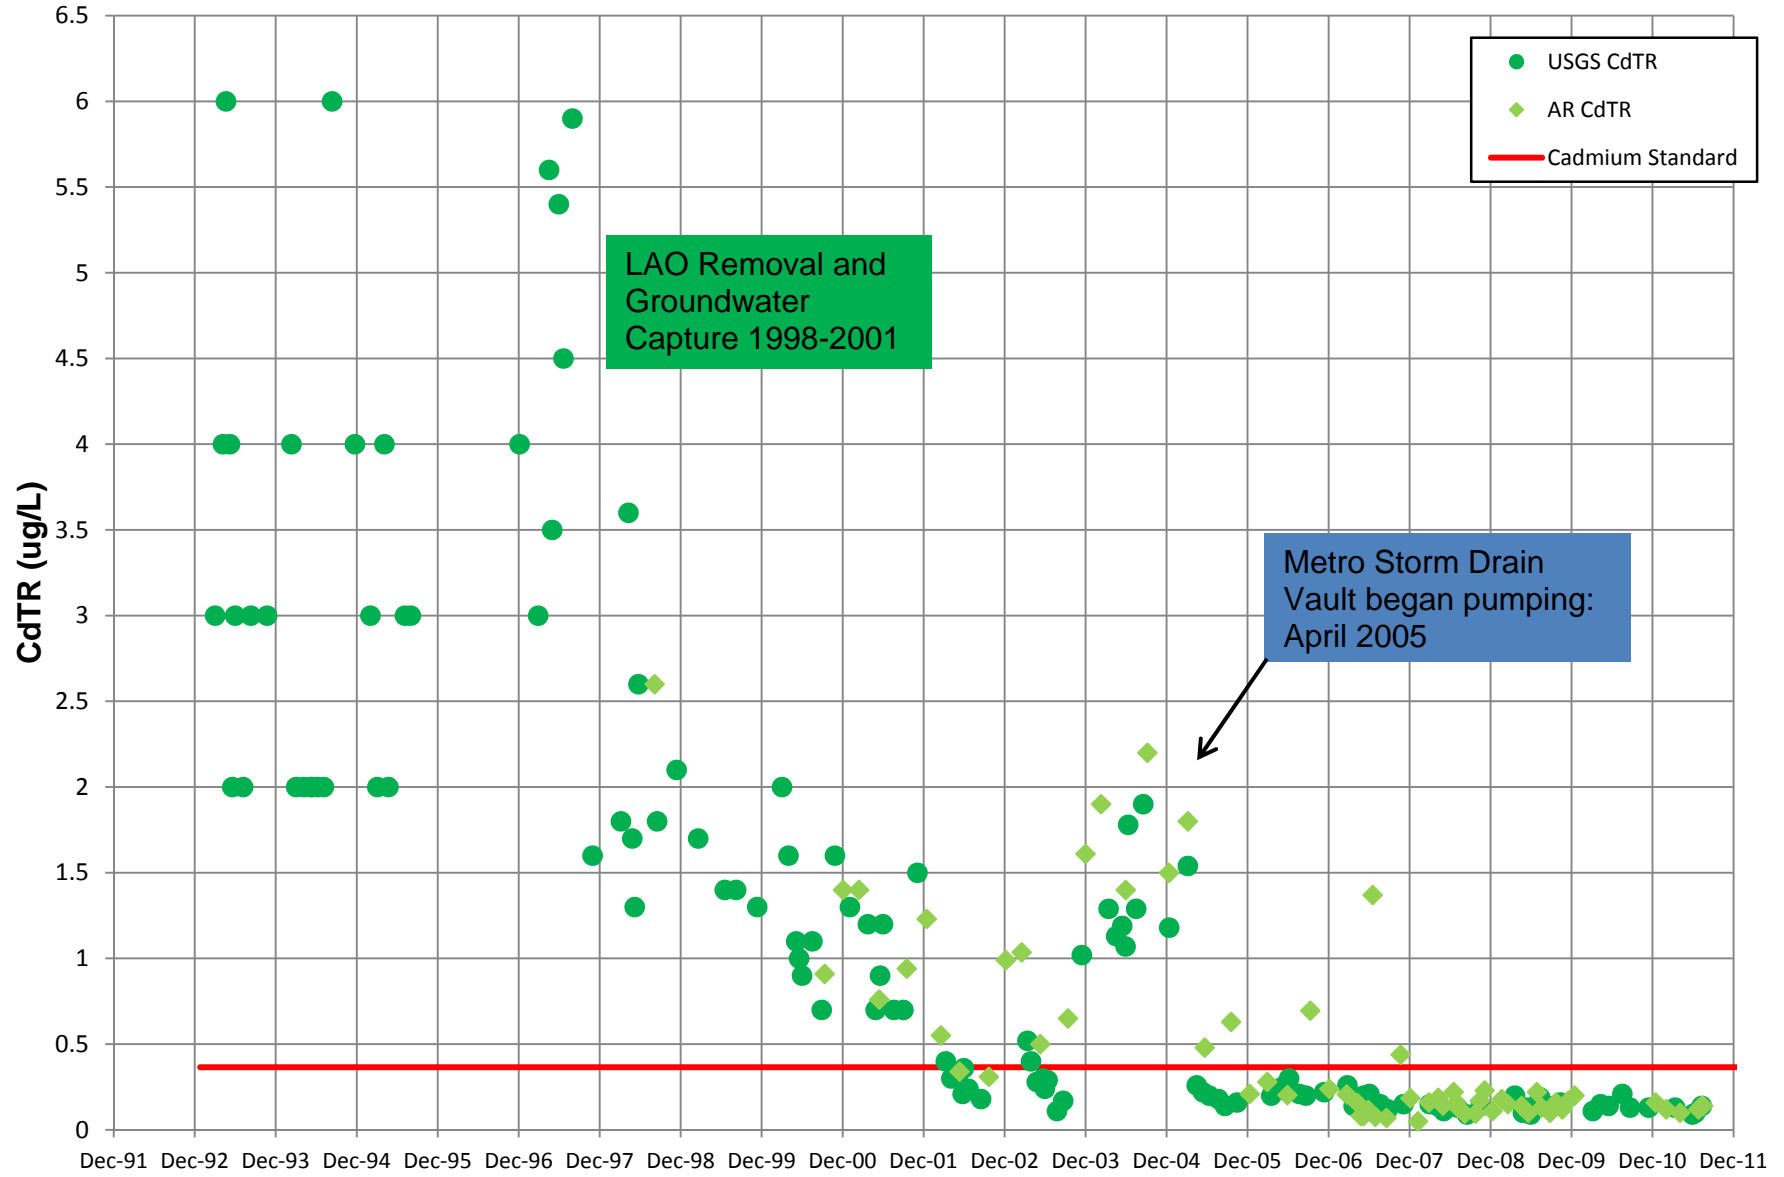
Surface Water Improvement in Silver Bow Creek CdTR during Base Flow Conditions at SS-07

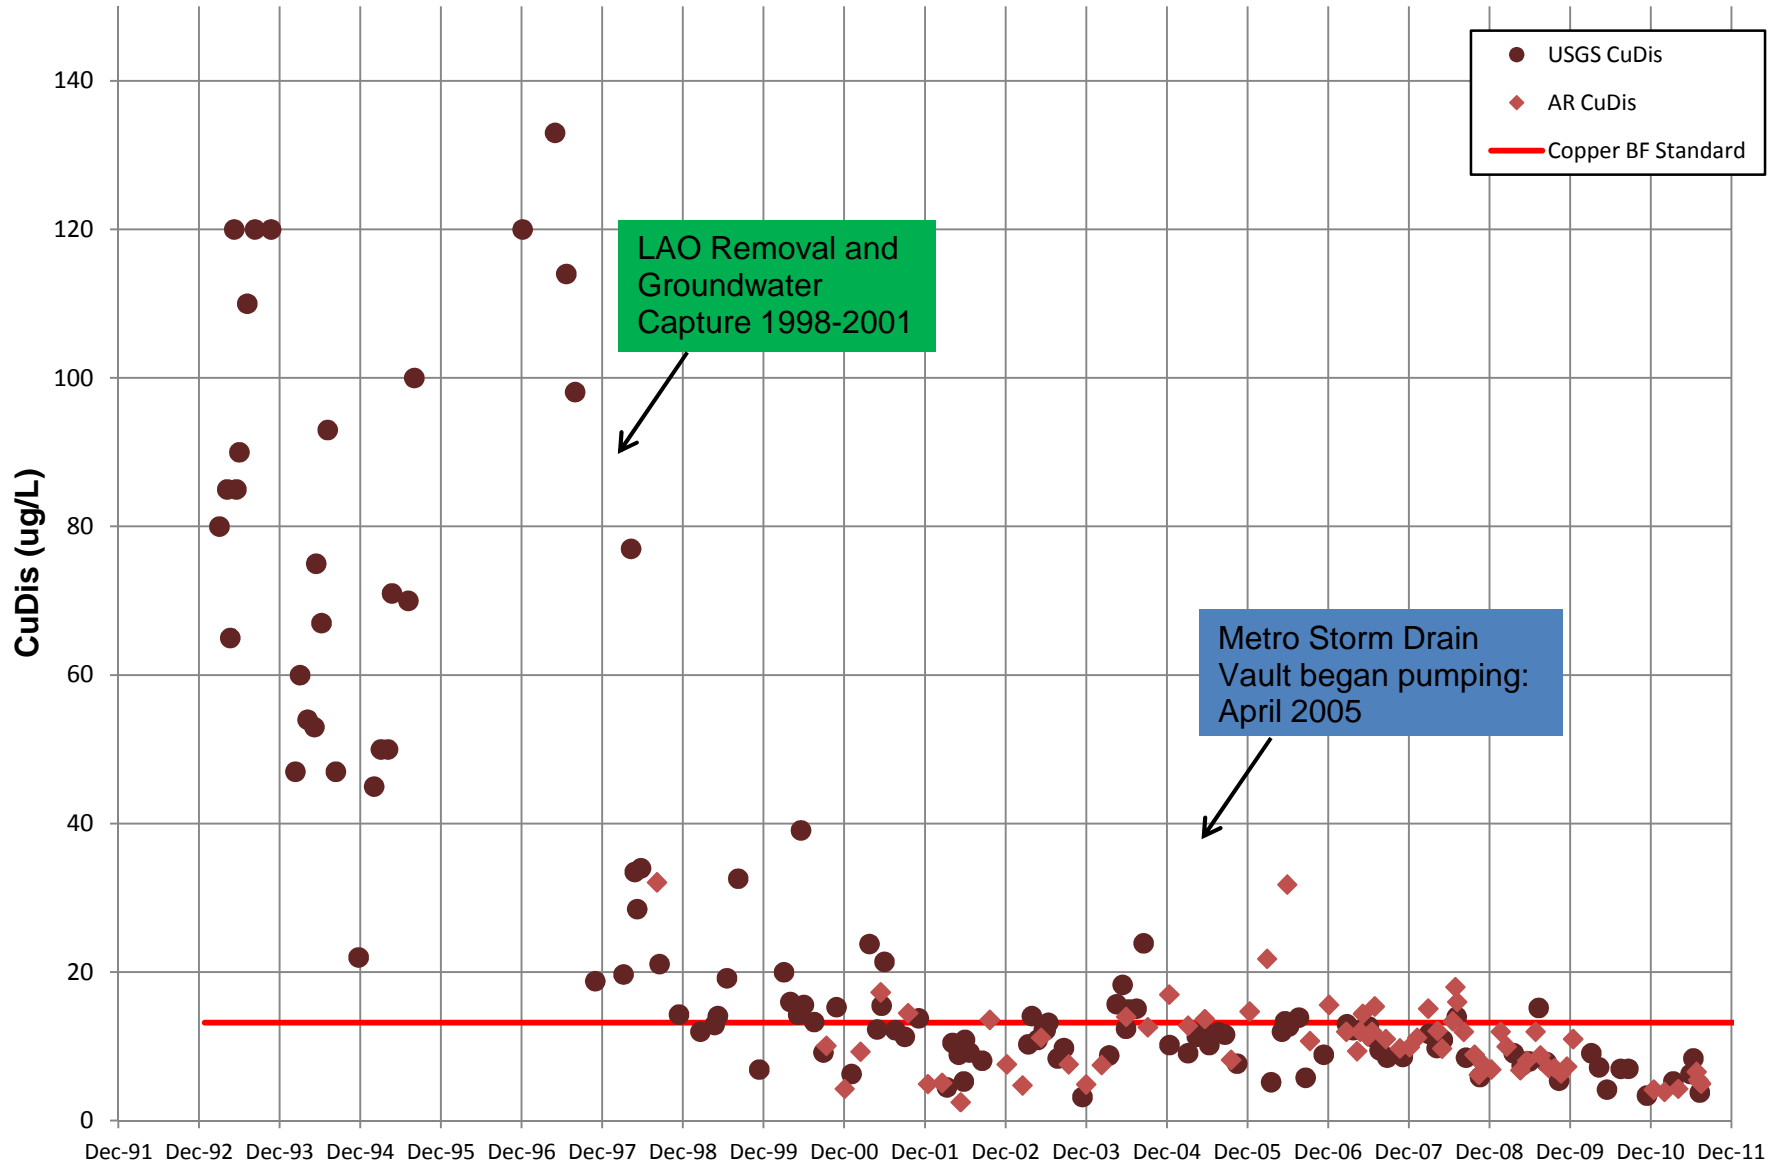
Surface Water Improvement in Silver Bow Creek CuDis during Base Flow Conditions at SS-07

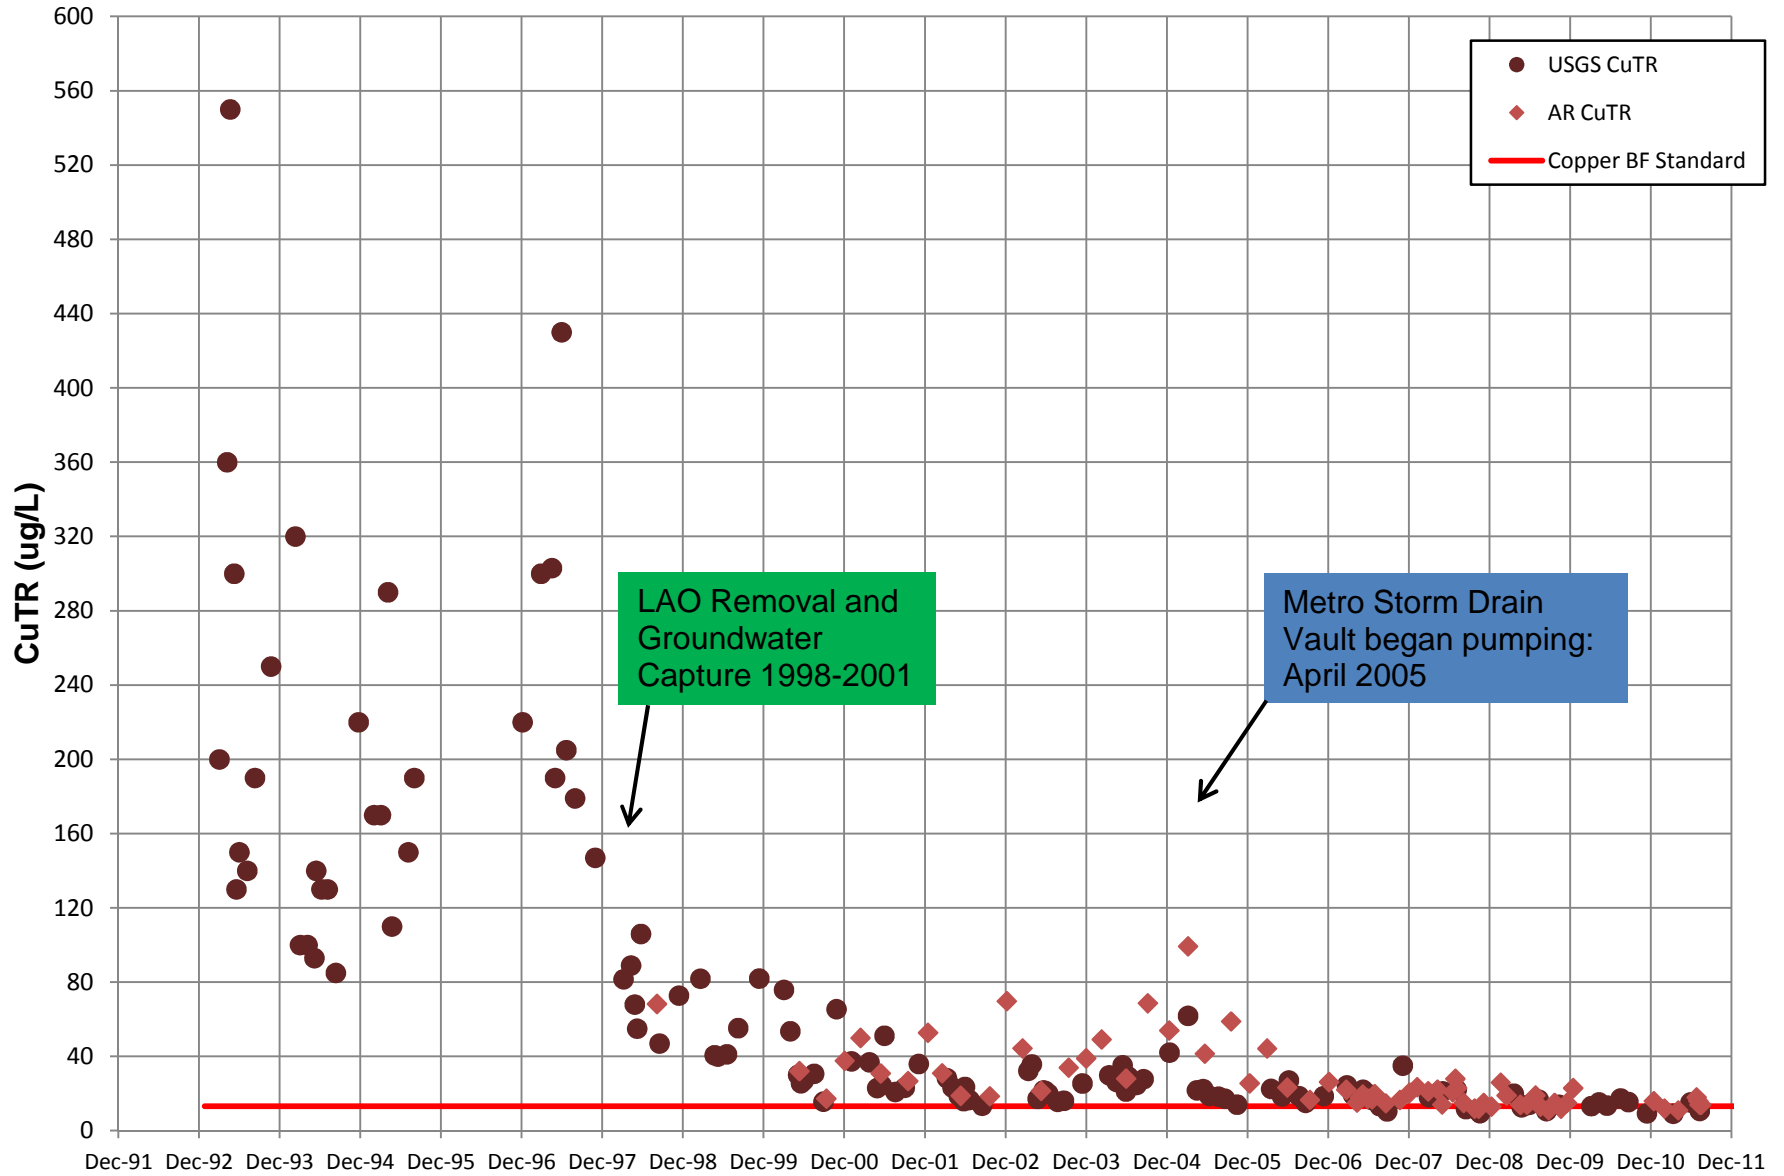
Surface Water Improvement in Silver Bow Creek CuTR during Base Flow Conditions at SS-07

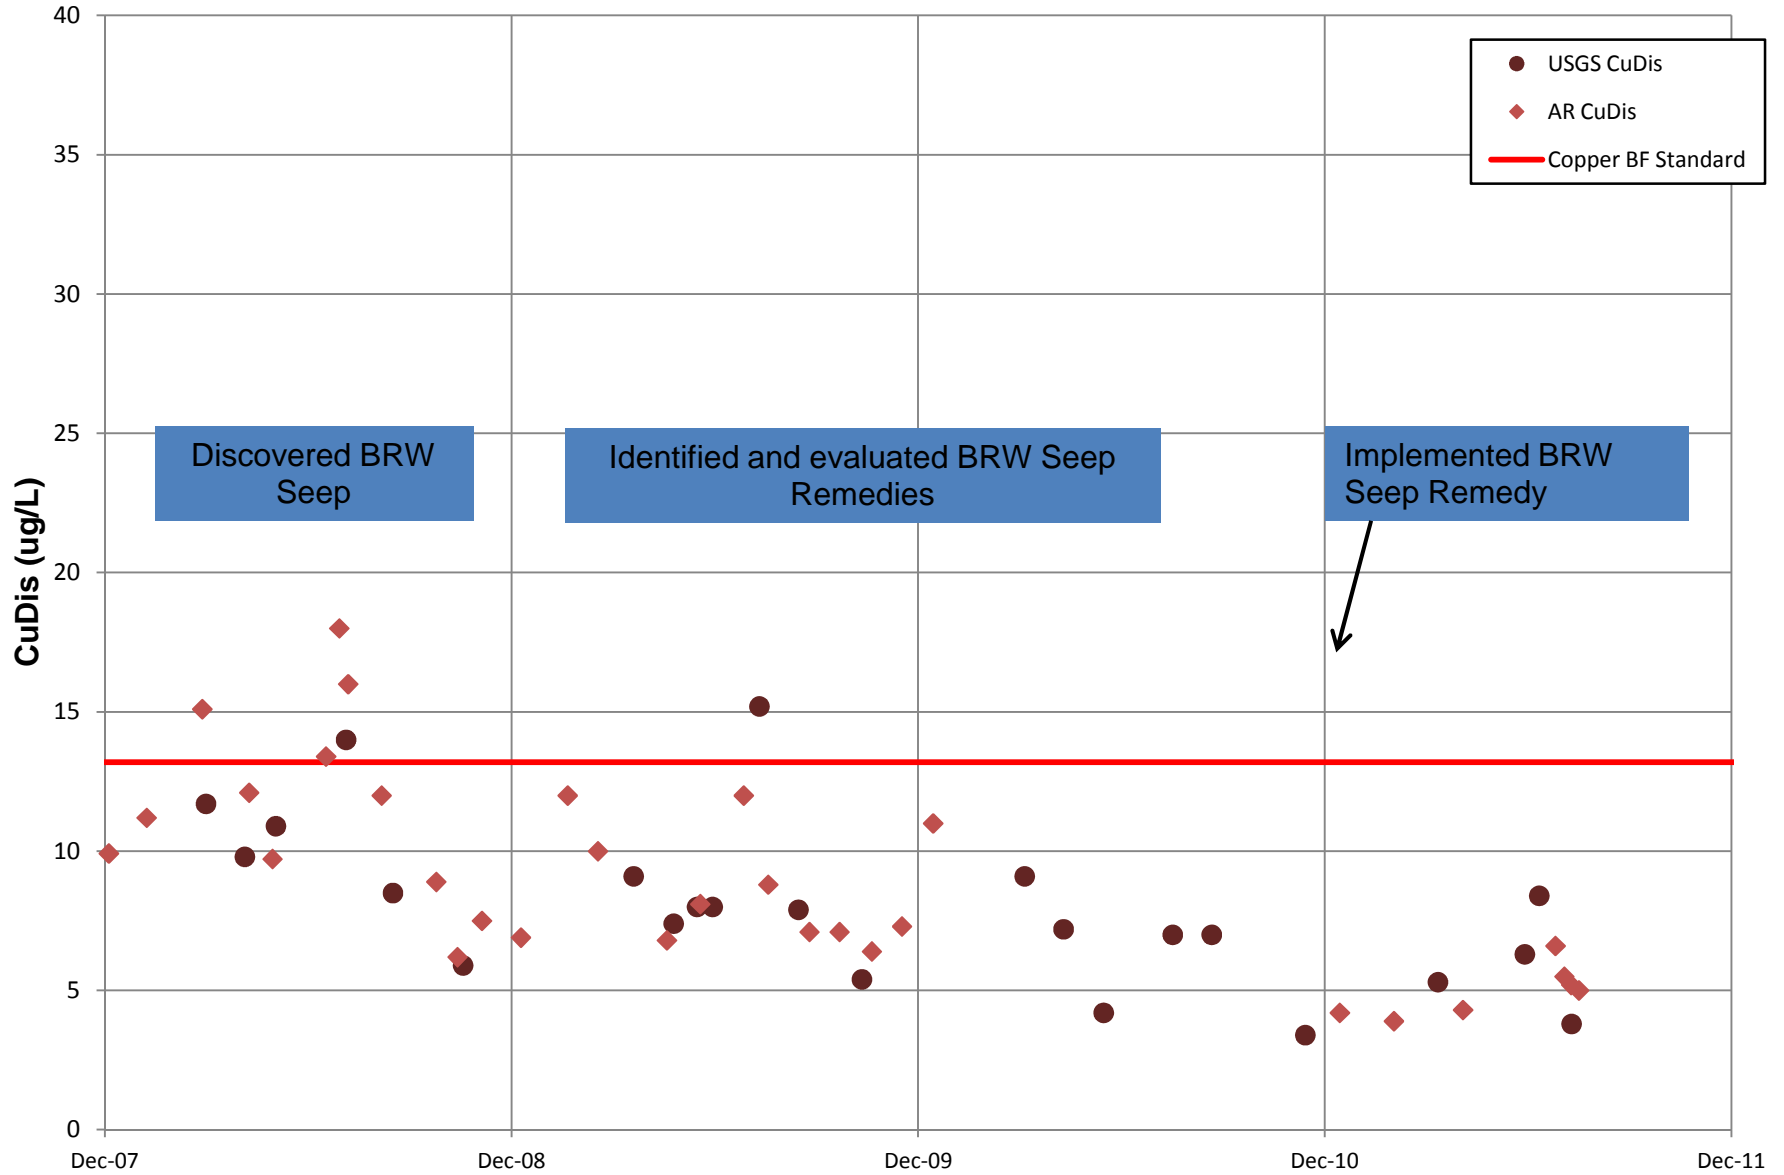
Surface Water Improvement in Silver Bow Creek CuDis during Base Flow Conditions at SS-07

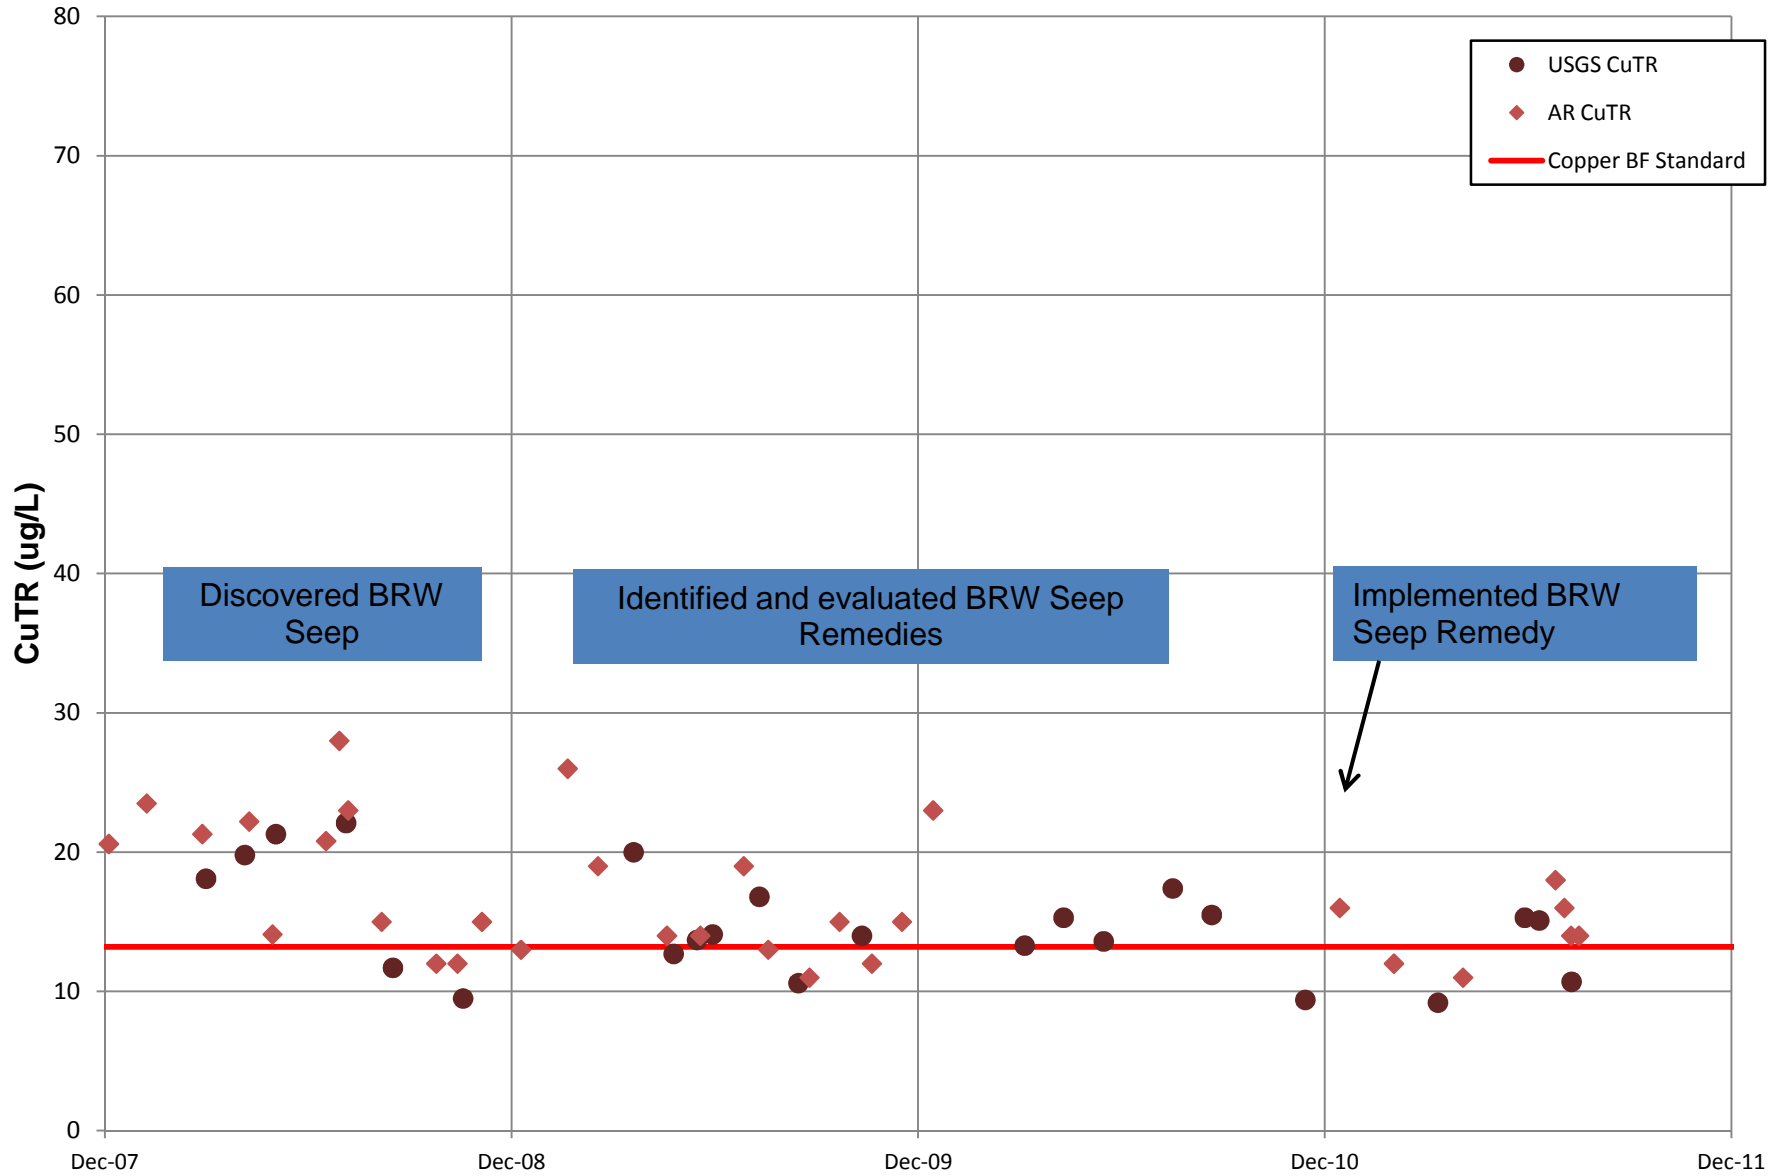
Surface Water Improvement in Silver Bow Creek CuTR during Base Flow Conditions at SS-07

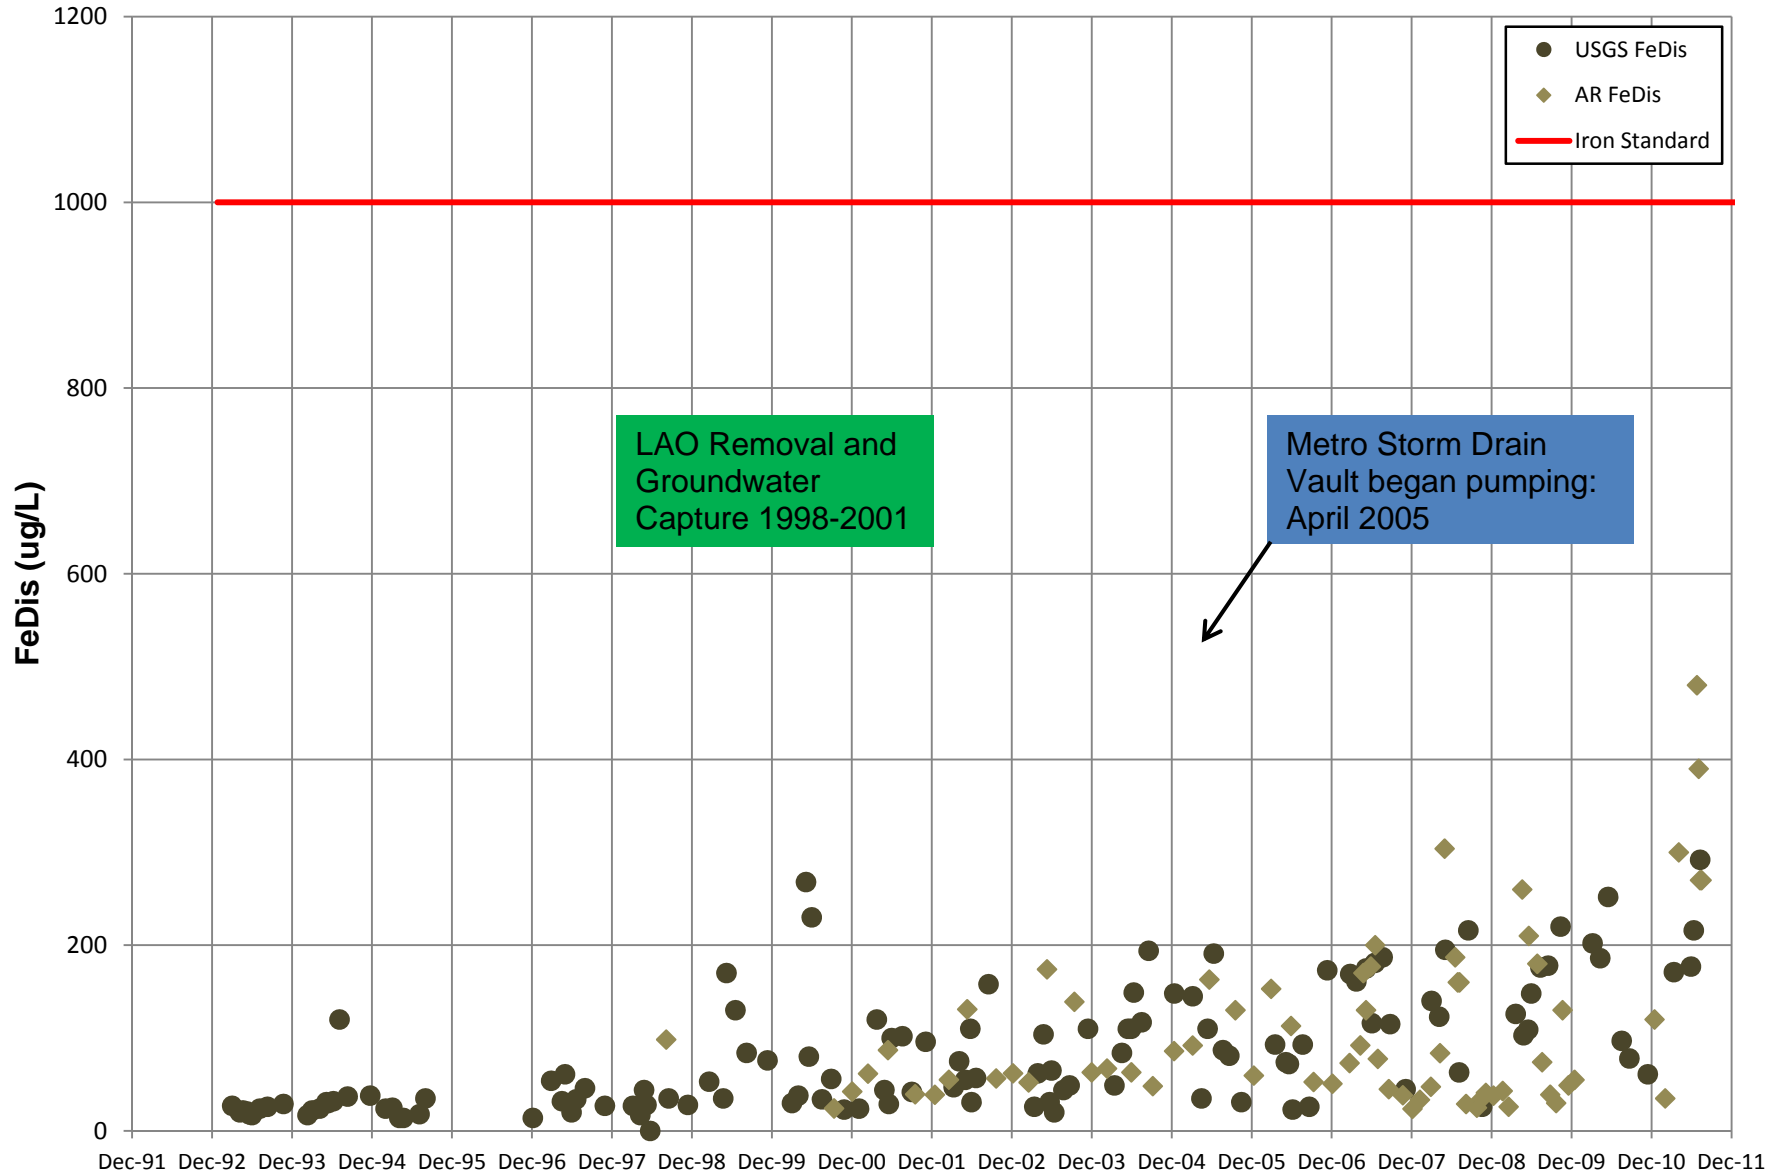
Surface Water Improvement in Silver Bow Creek FeDis during Base Flow Conditions at SS-07

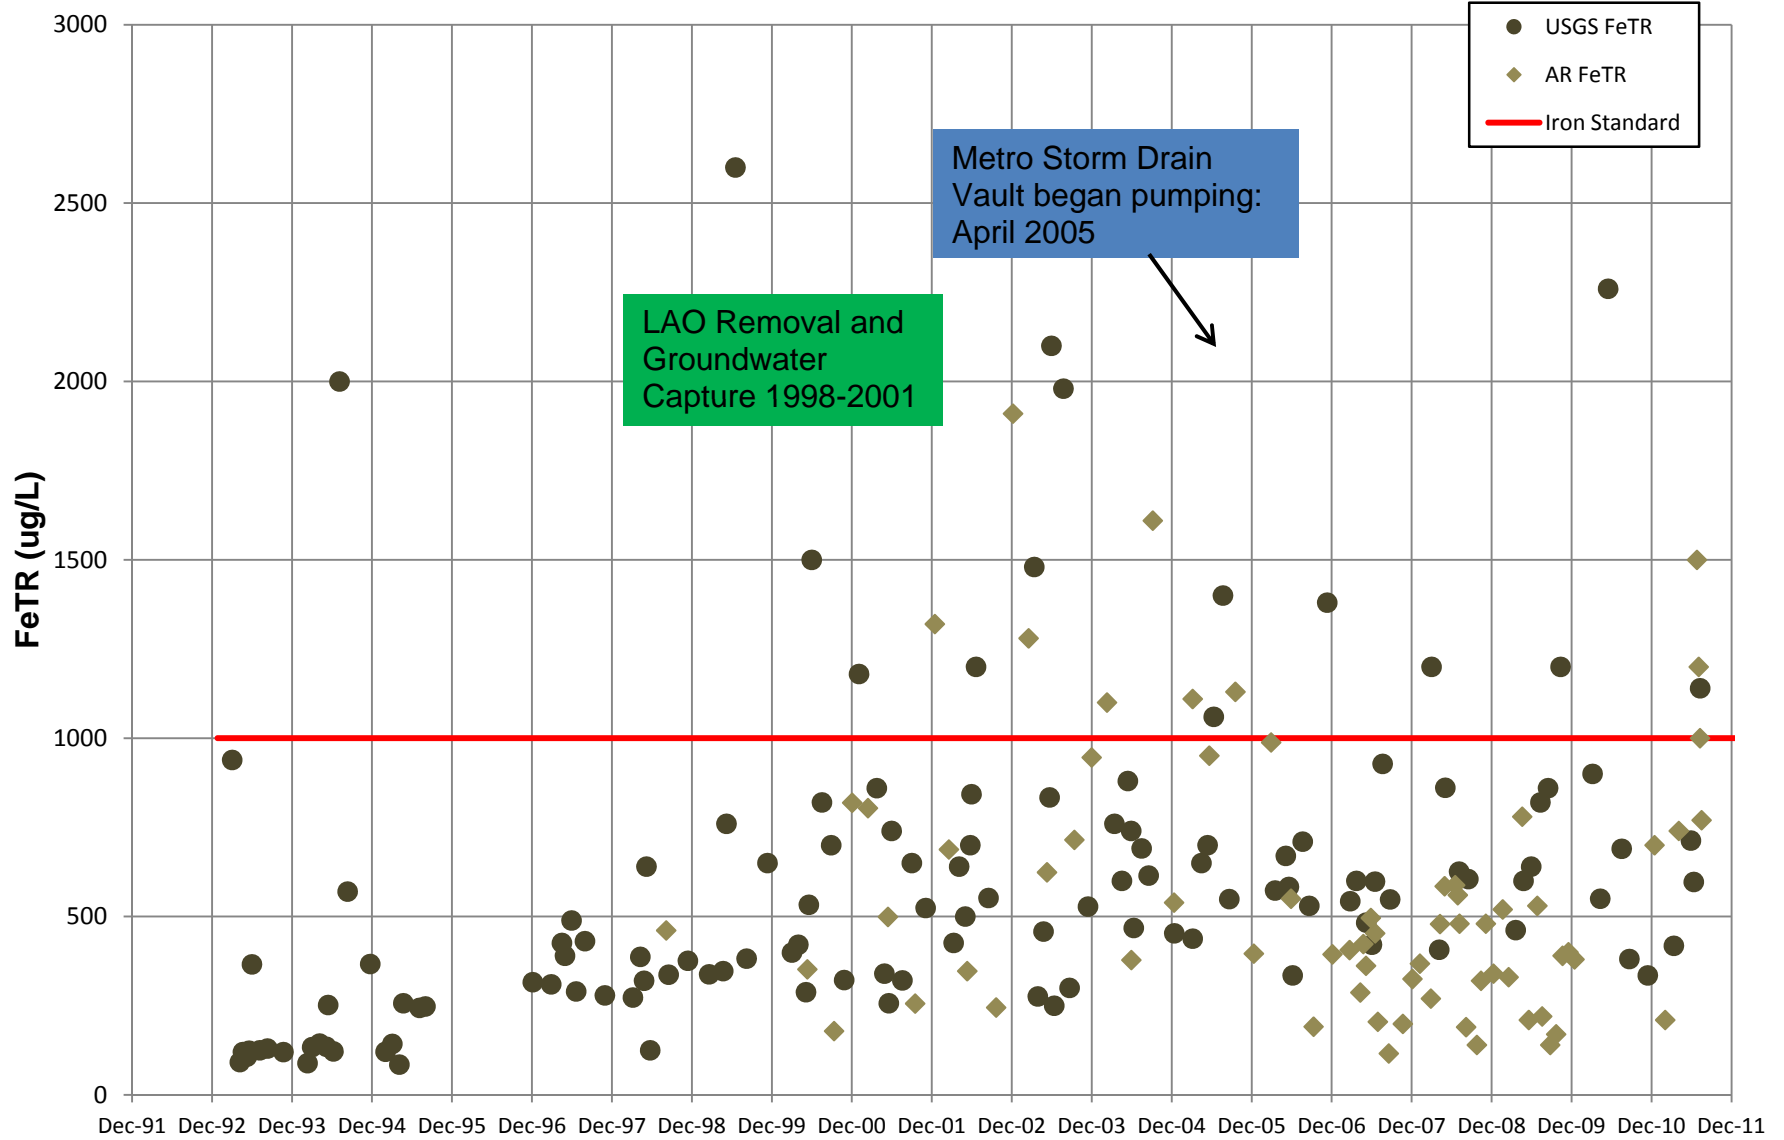
Surface Water Improvement in Silver Bow Creek FeTR during Base Flow Conditions at SS-07 No Outliers

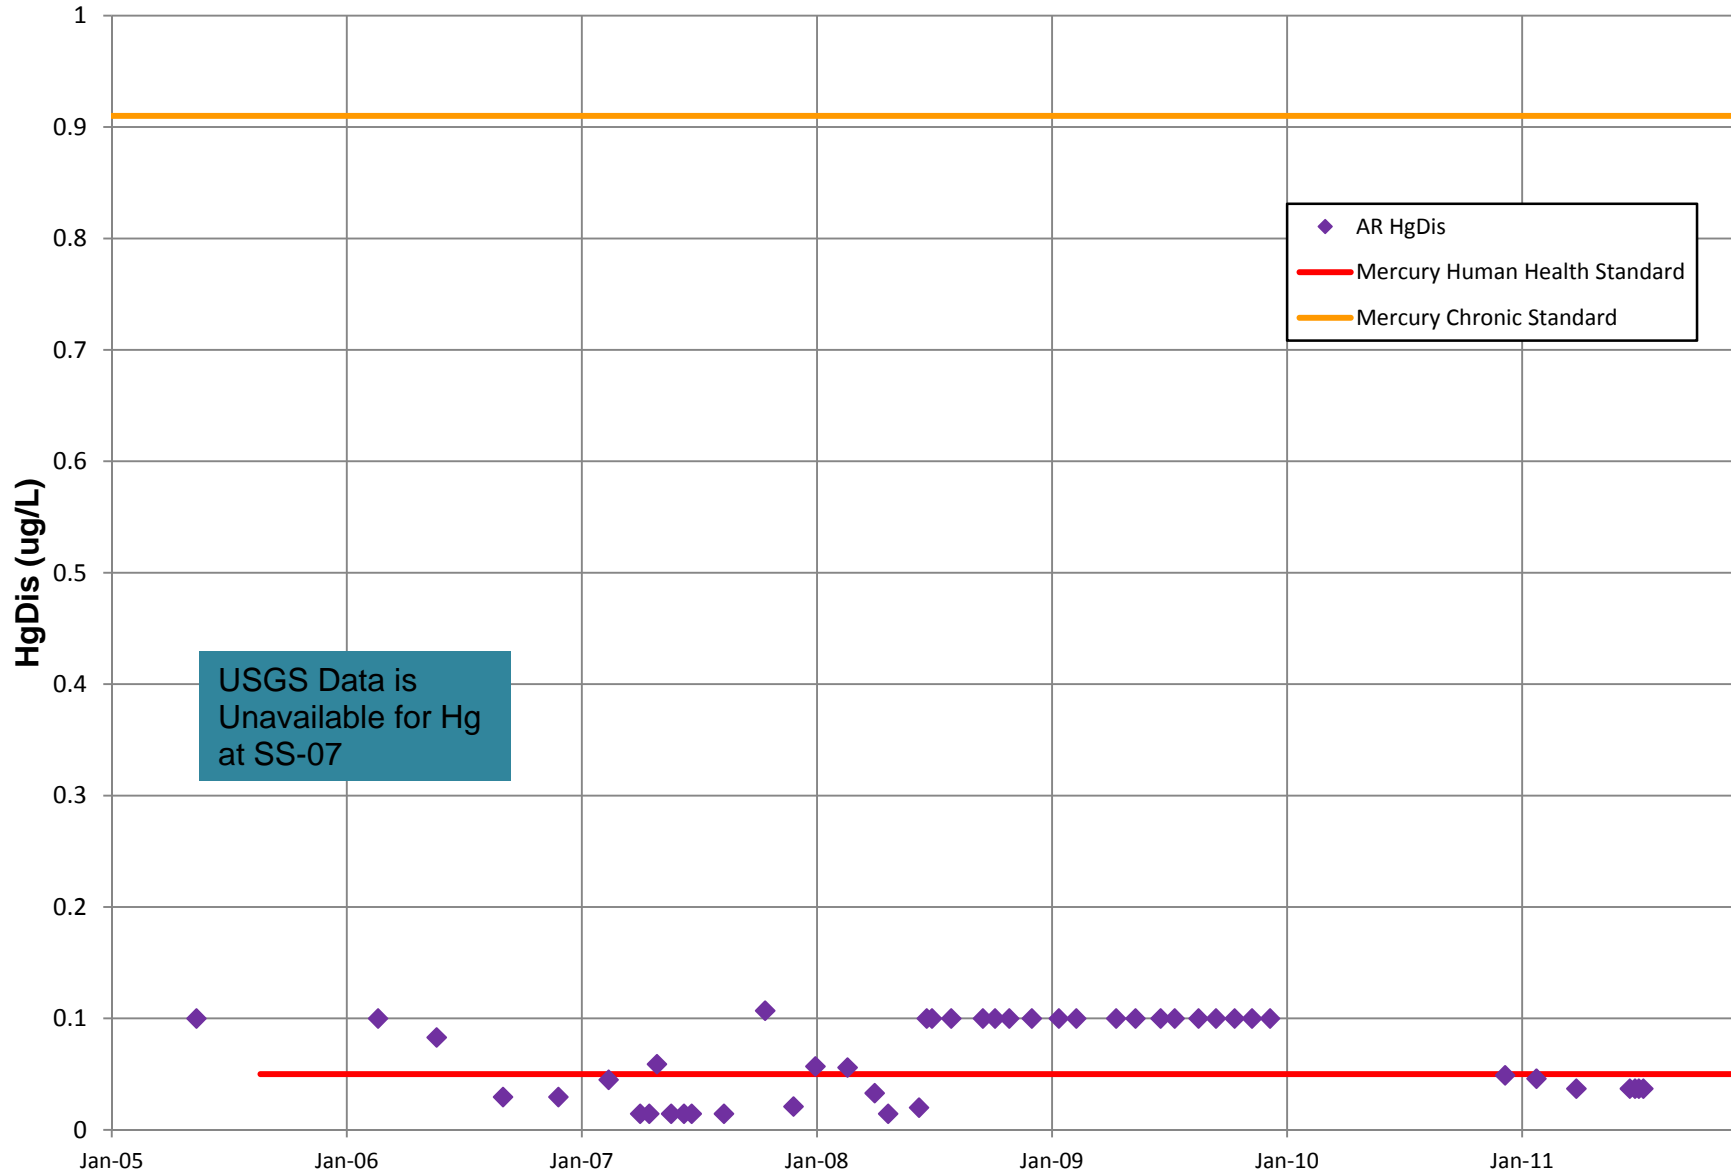
Surface Water Improvement in Silver Bow Creek HgDis during Base Flow Conditions at SS-07

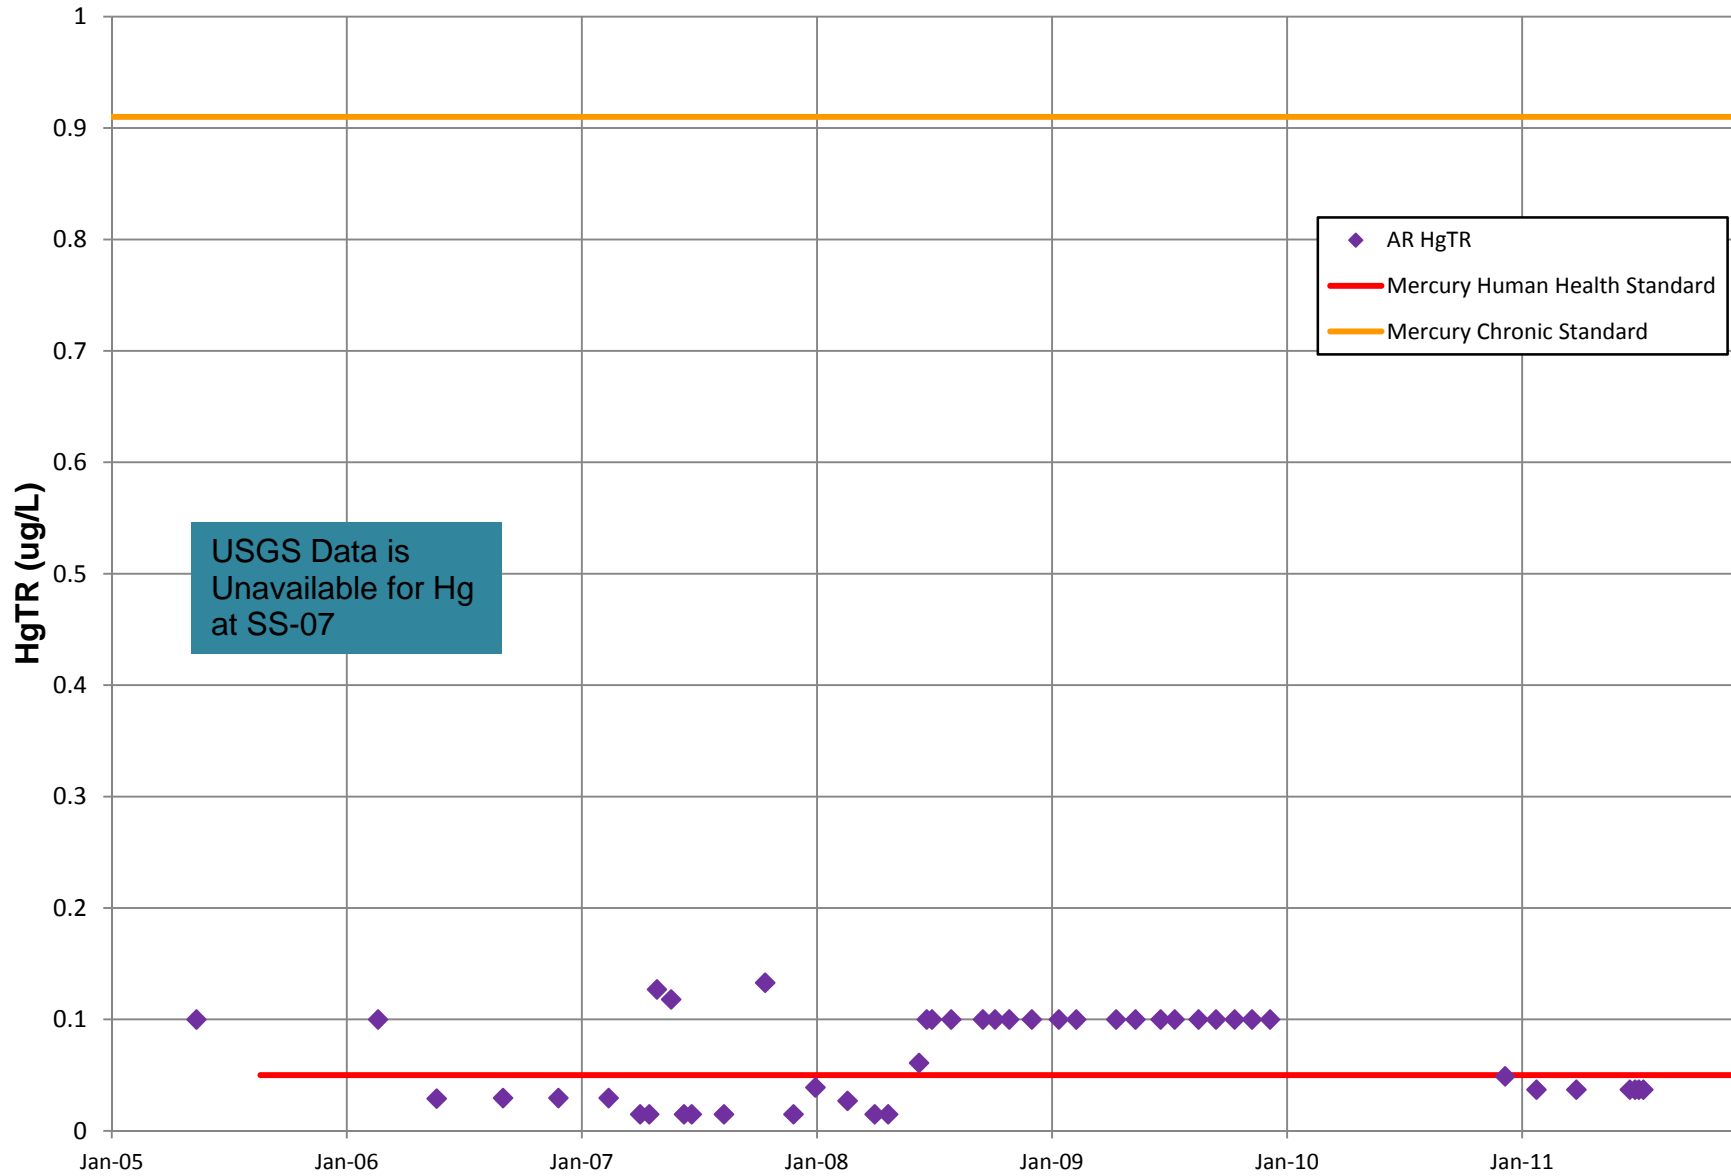
Surface Water Improvement in Silver Bow Creek HgTR during Base Flow Conditions at SS-07
