Surface Water Improvement in Silver Bow Creek AsDis during Base Flow Conditions at SS-07

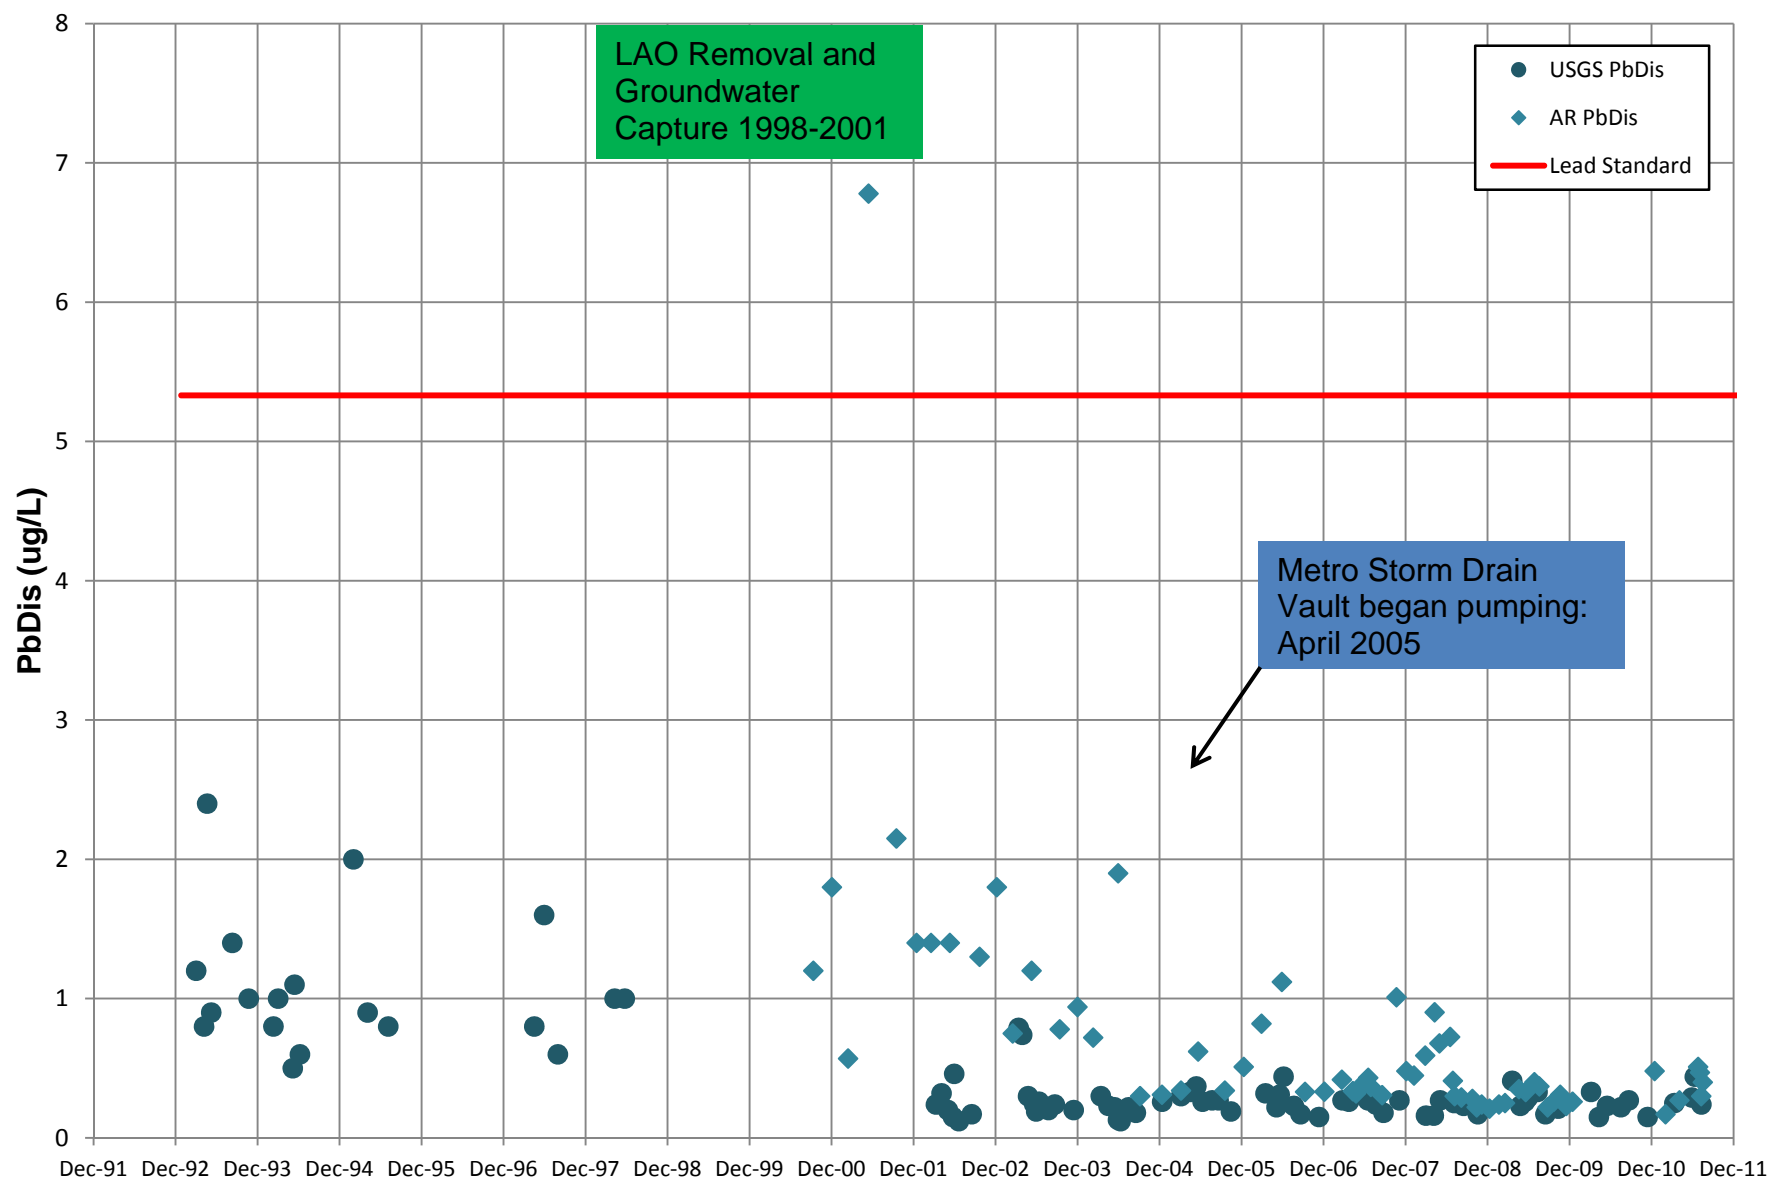
Surface Water Improvement in Silver Bow Creek PbDis during Base Flow Conditions at SS-07

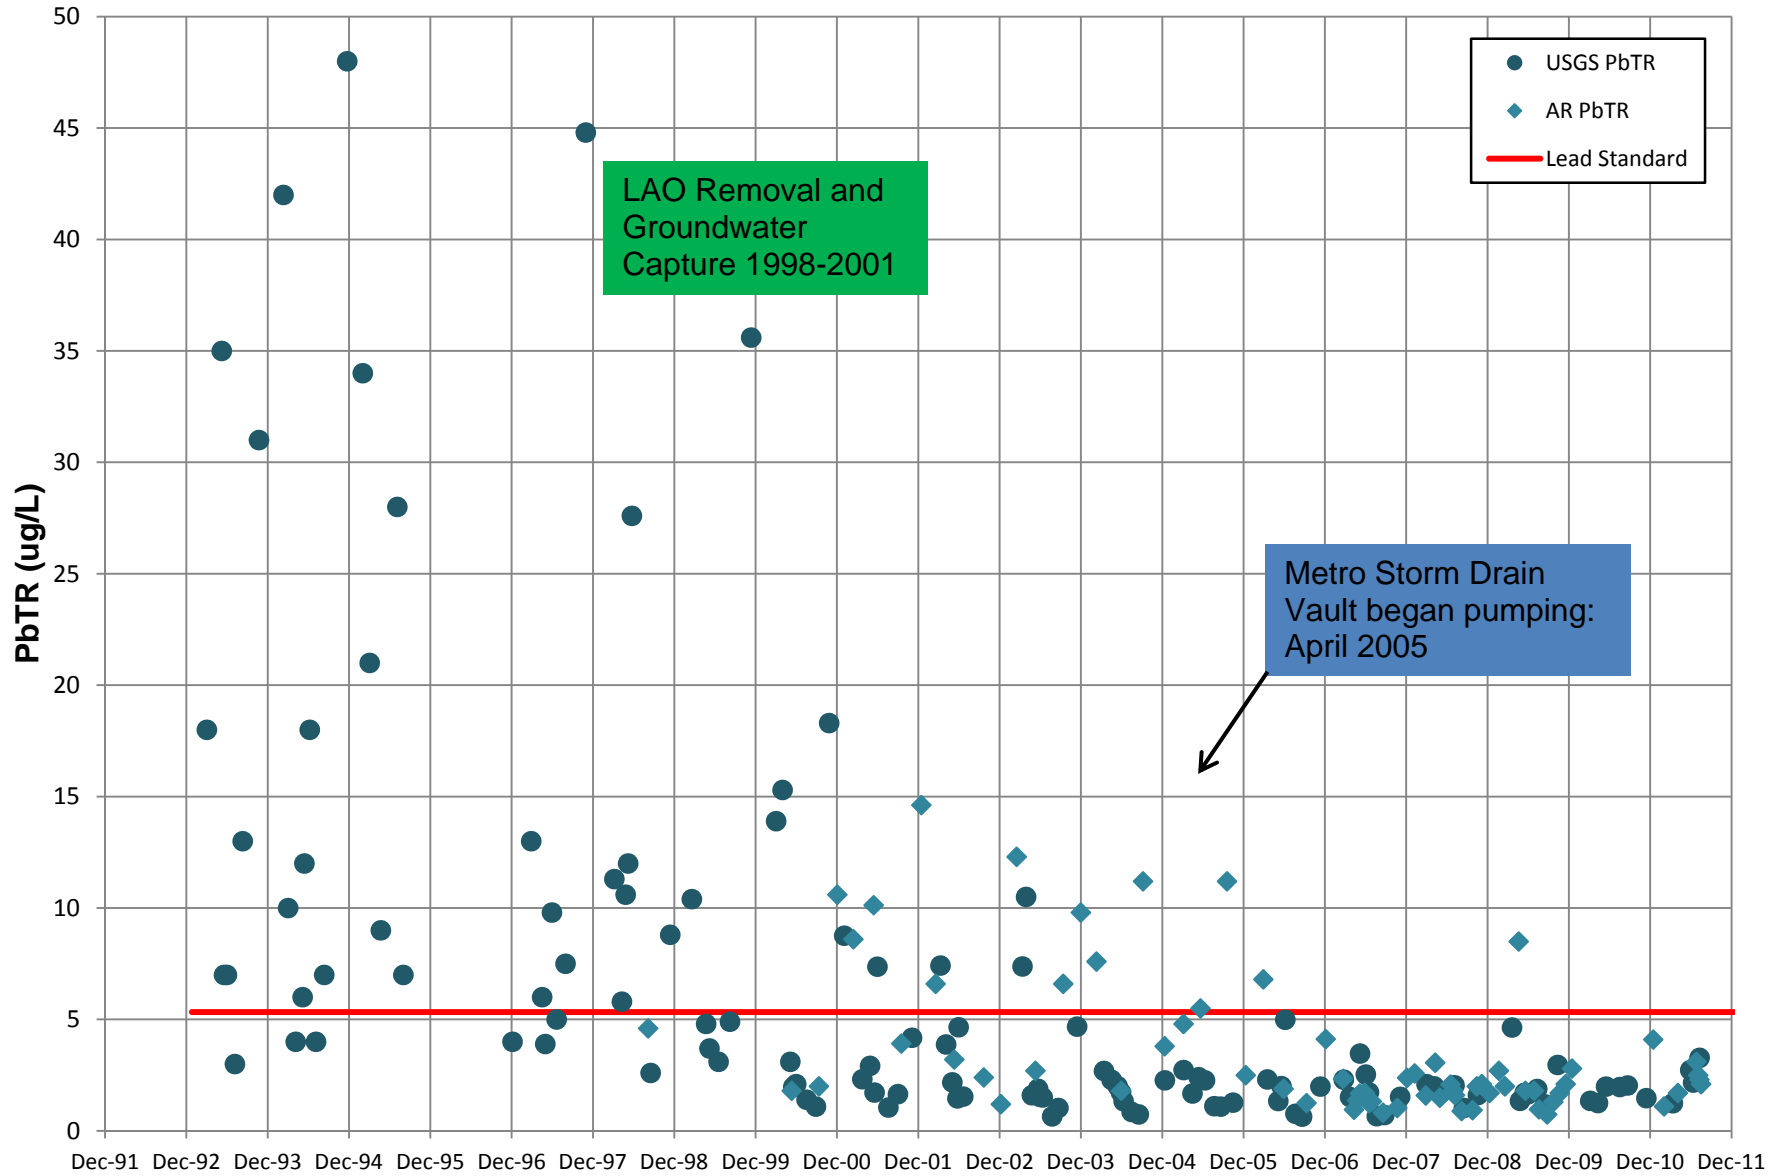
Surface Water Improvement in Silver Bow Creek PbTR during Base Flow Conditions at SS-07

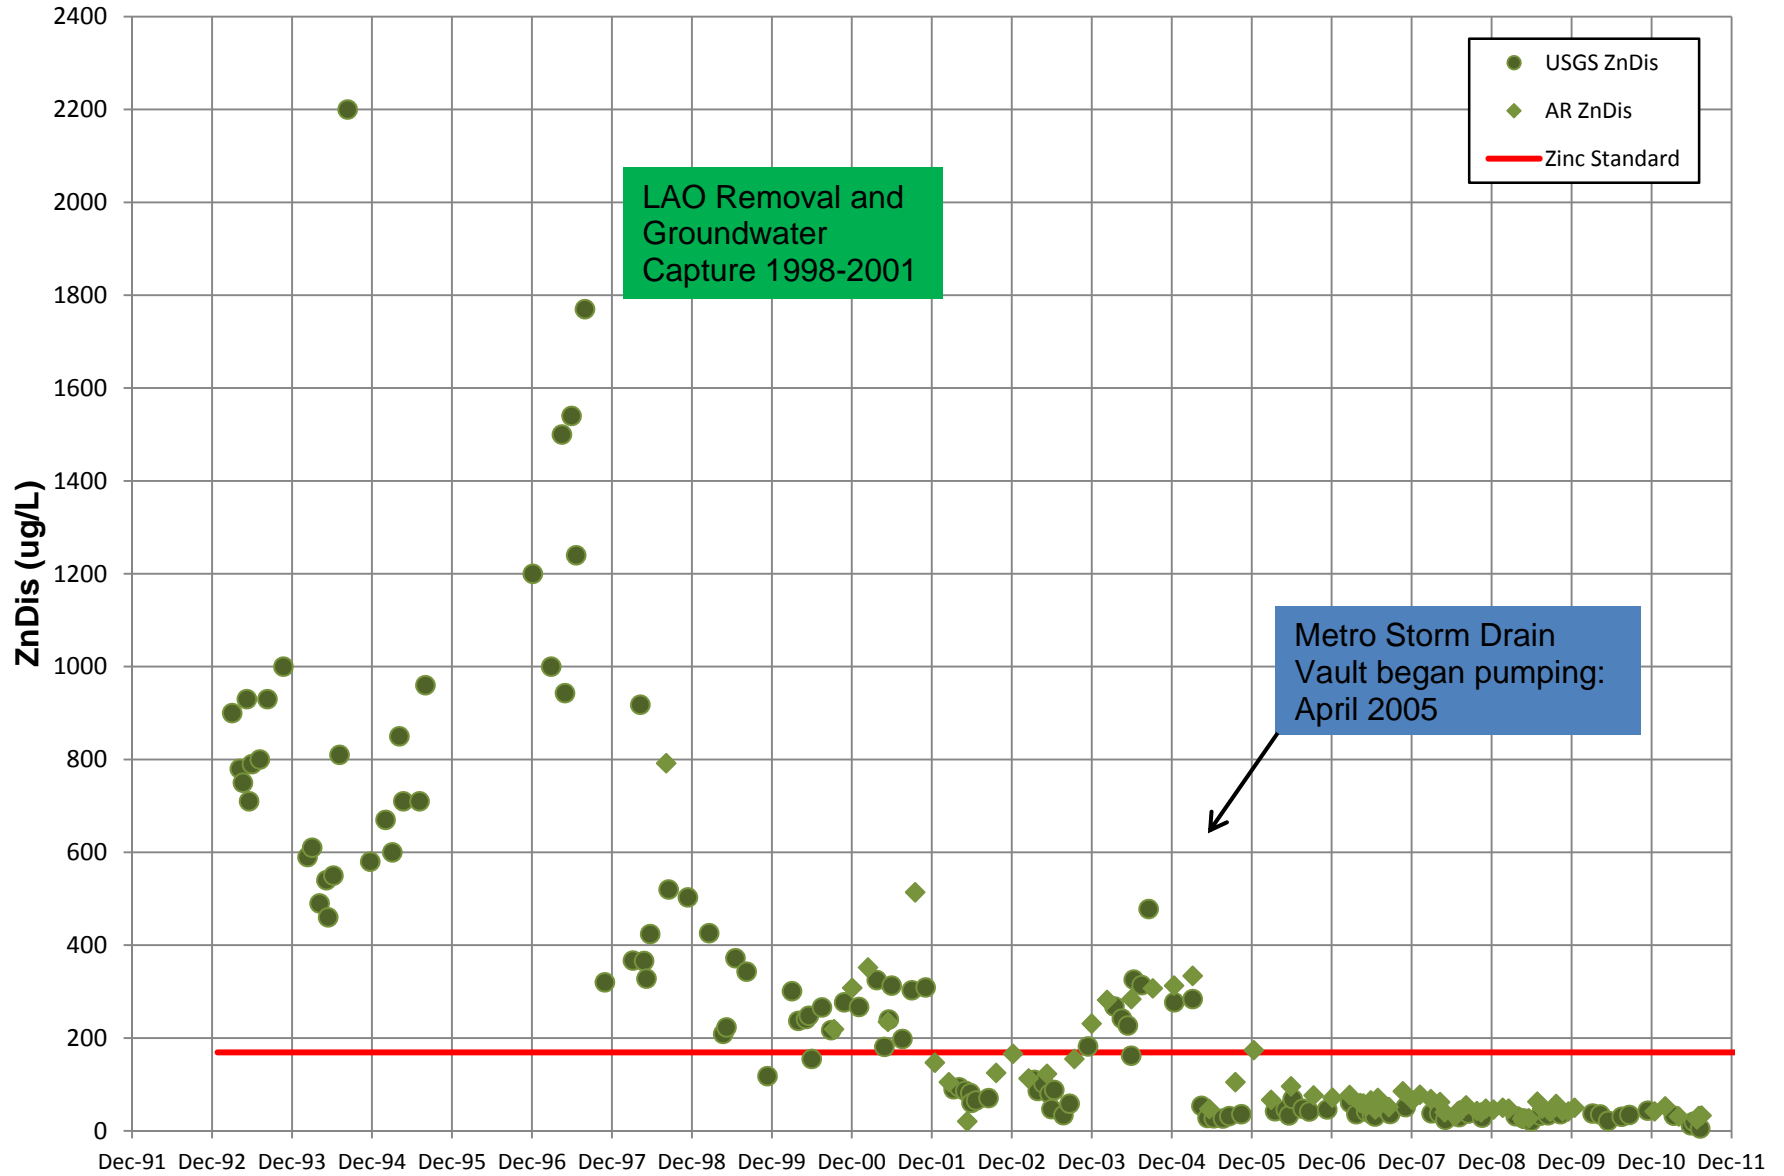
Surface Water Improvement in Silver Bow Creek ZnDis during Base Flow Conditions at SS-07

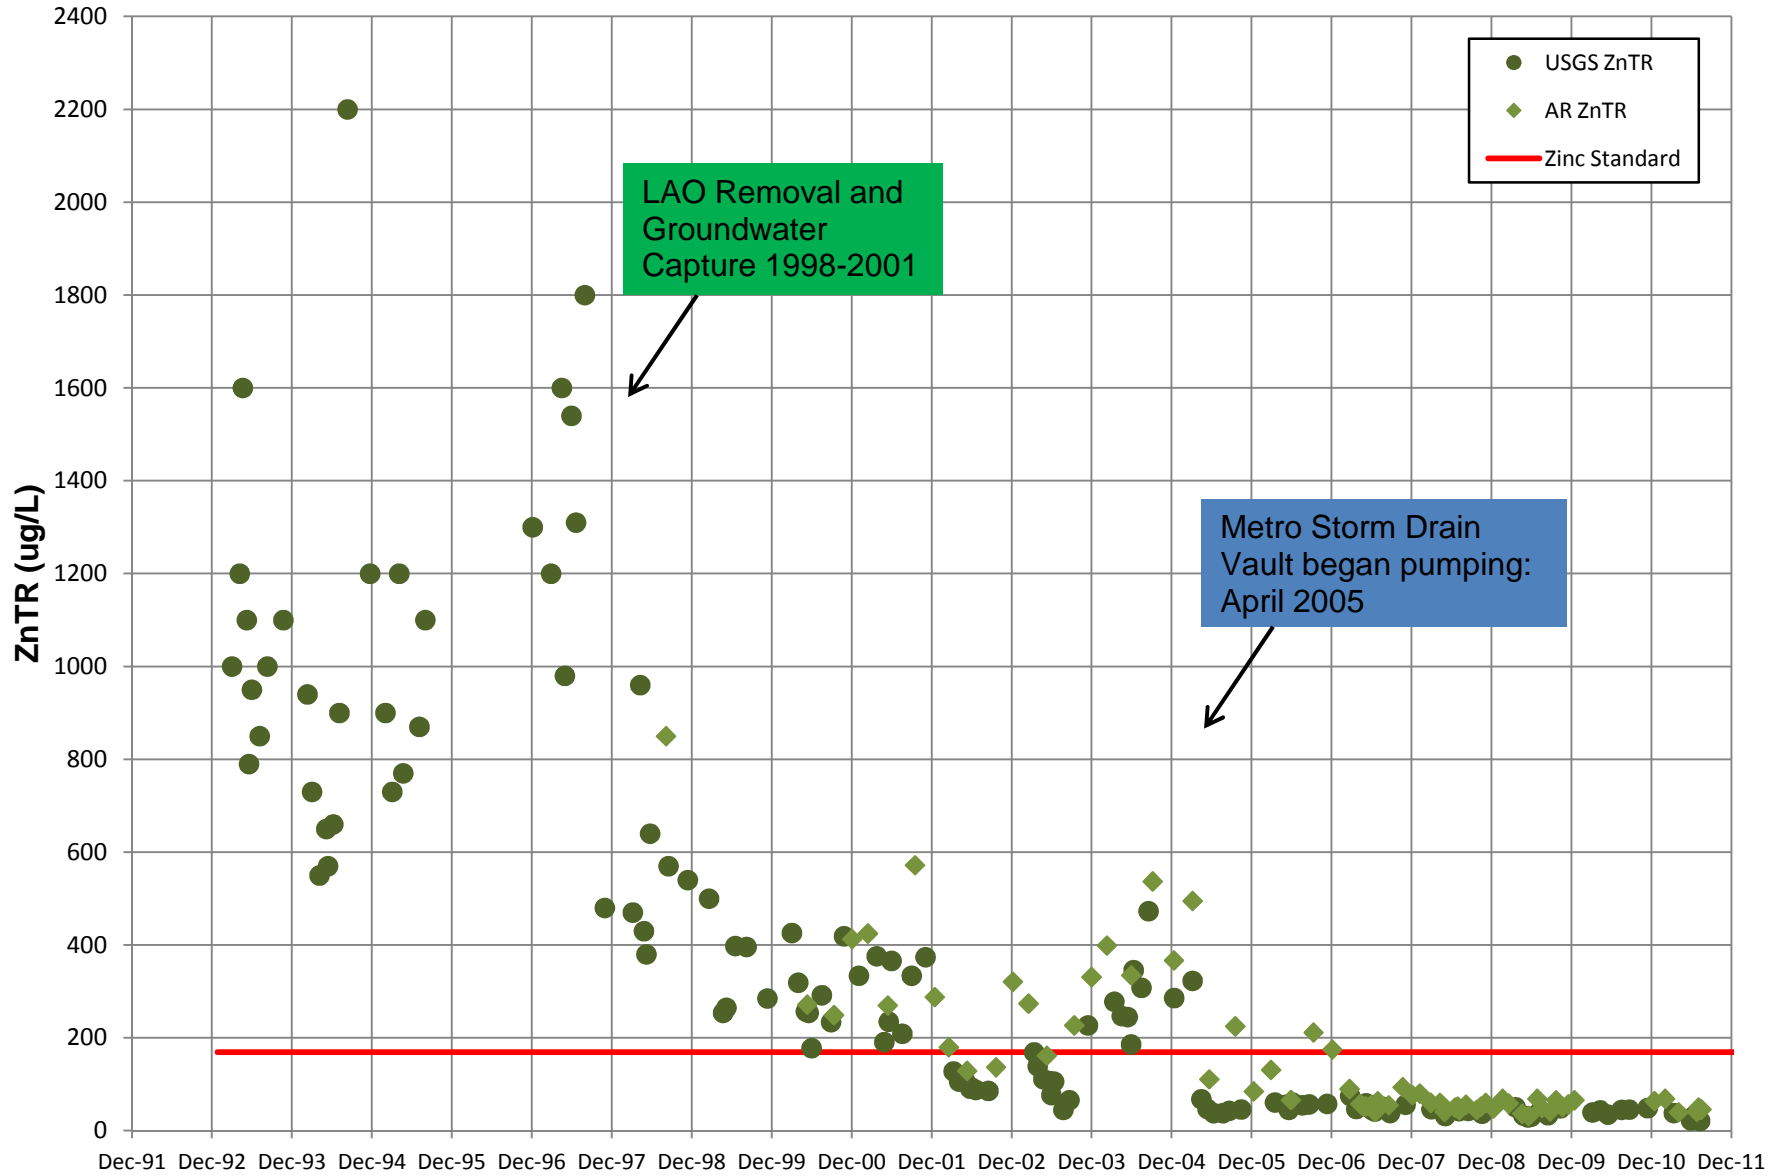
Surface Water Improvement in Silver Bow Creek ZnTR during Base Flow Conditions at SS-07
