Surface Water Improvement in Silver Bow Creek AsDis during Base Flow Conditions at SS-07

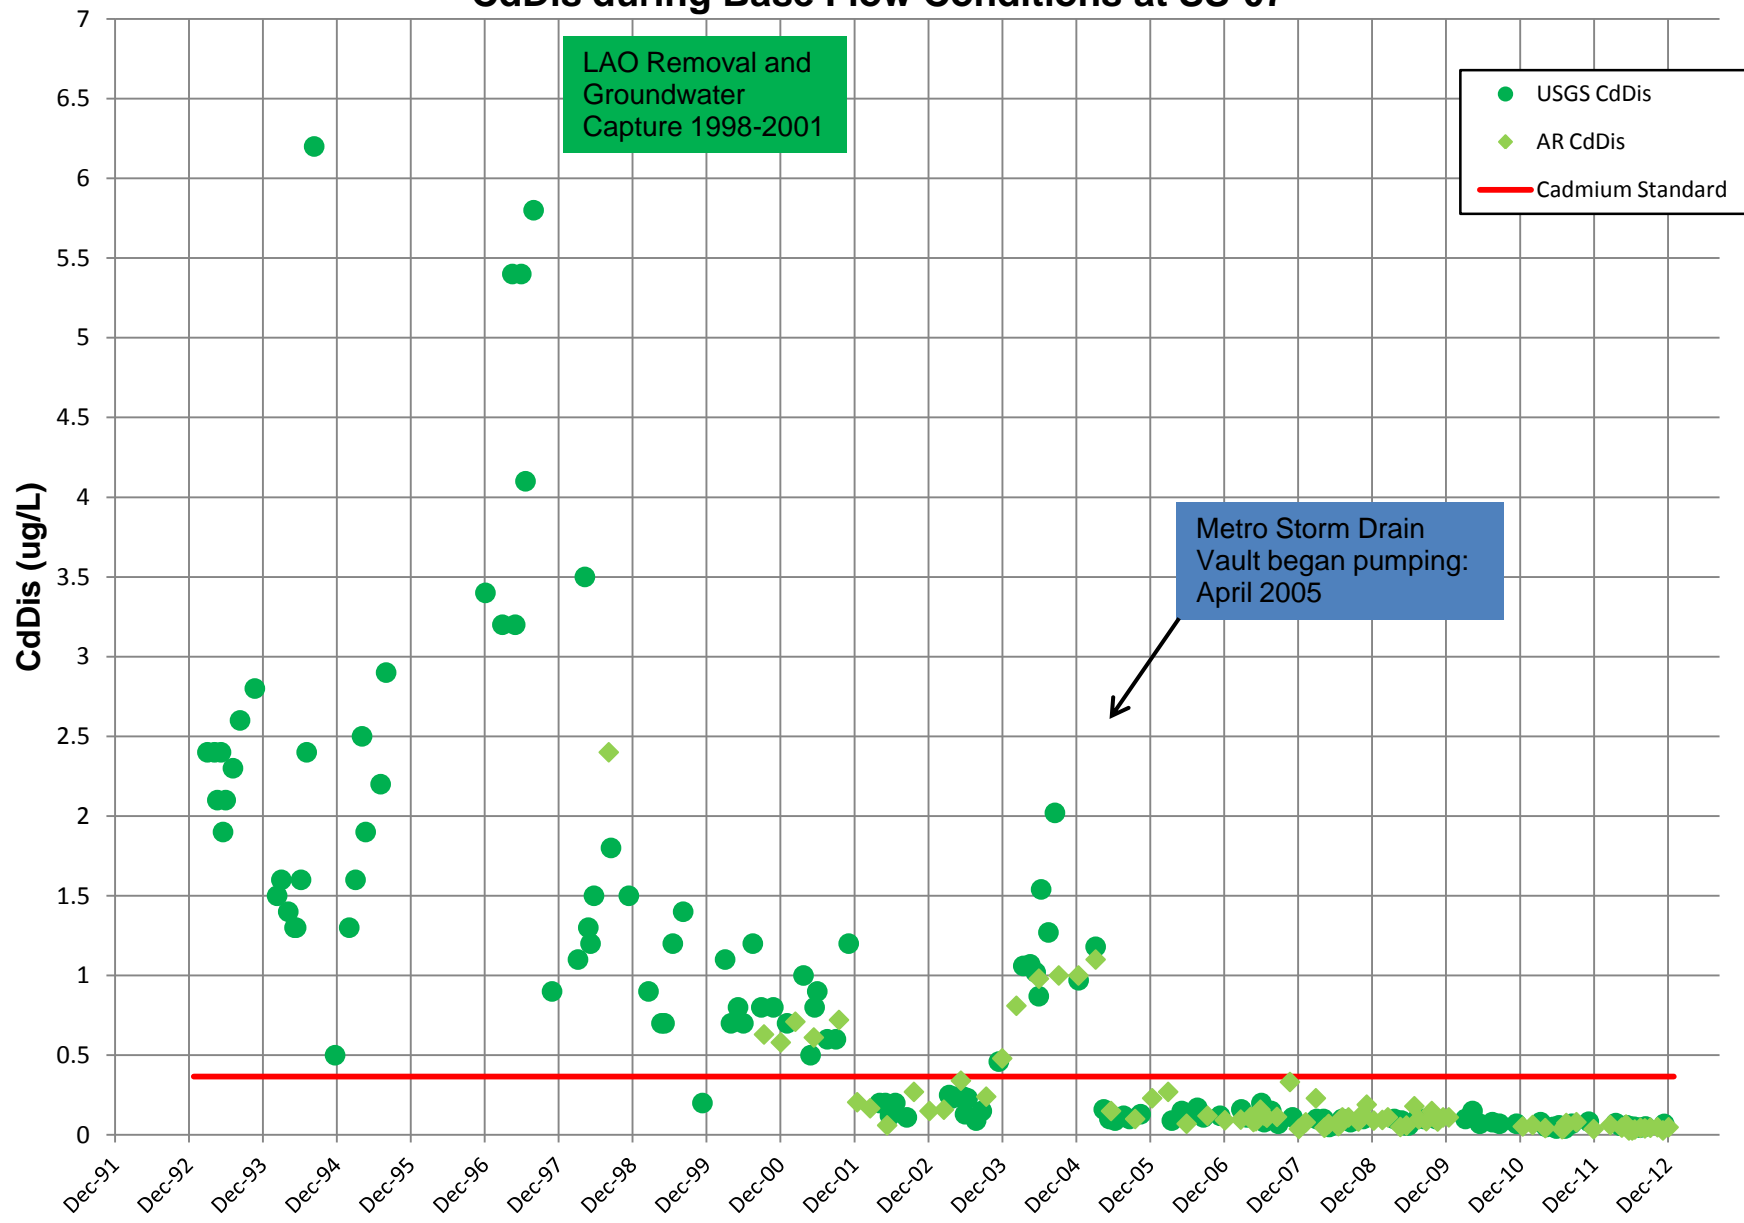
Surface Water Improvement in Silver Bow Creek CdDis during Base Flow Conditions at SS-07

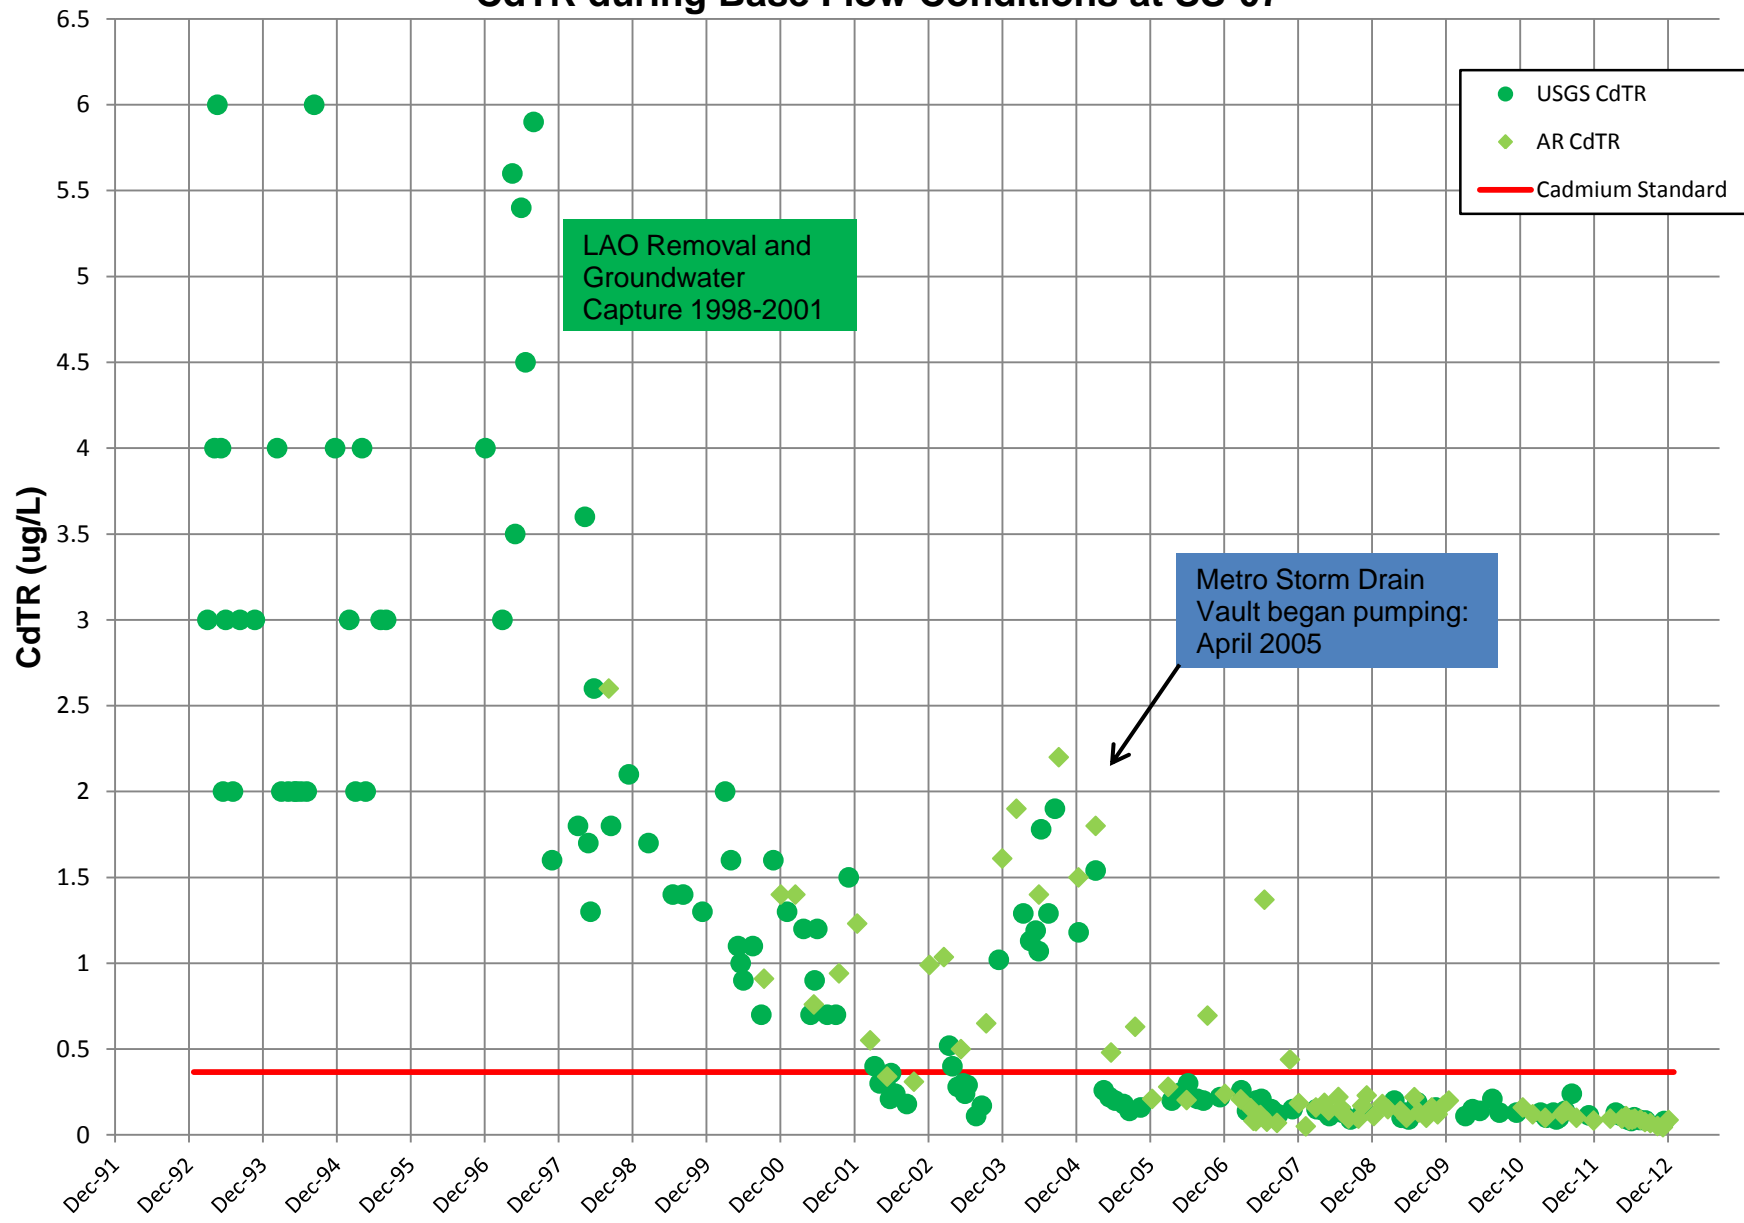
Surface Water Improvement in Silver Bow Creek CdTR during Base Flow Conditions at SS-07

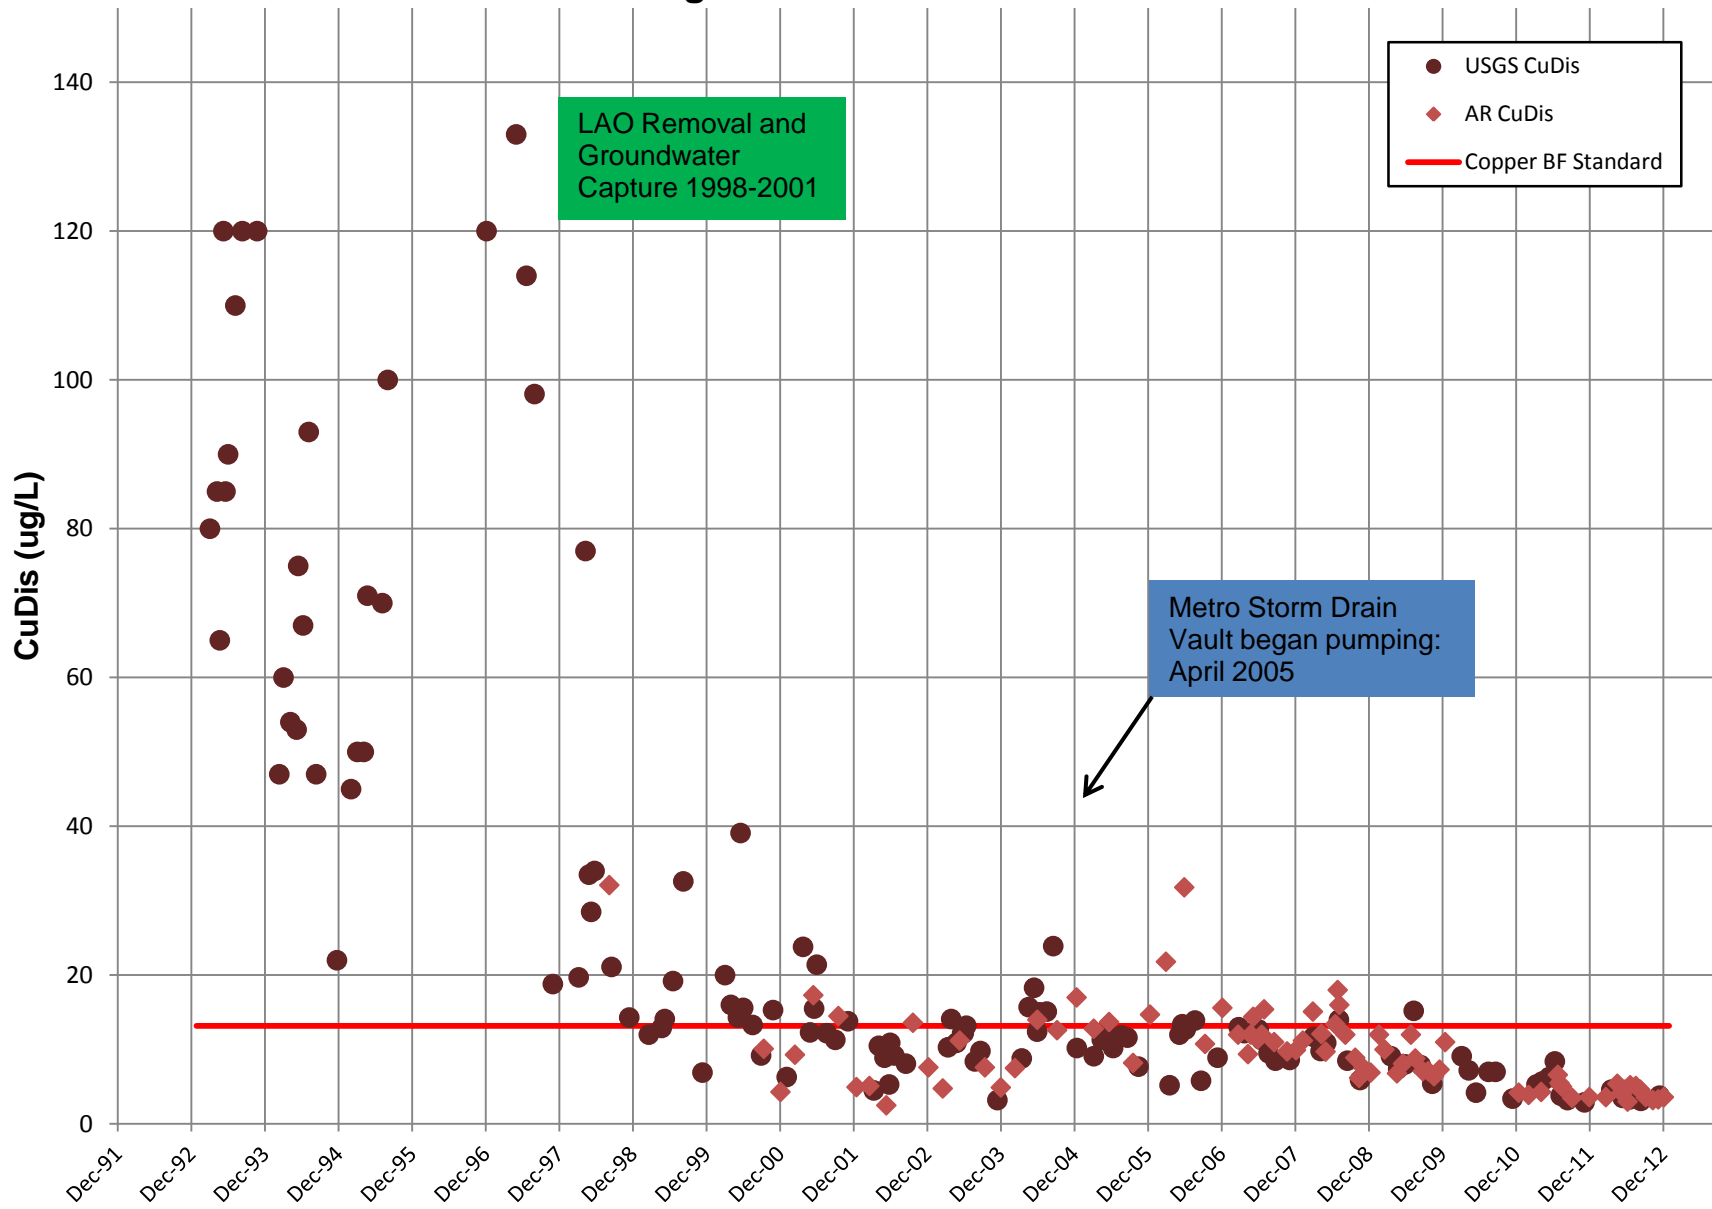
Surface Water Improvement in Silver Bow Creek CuDis during Base Flow Conditions at SS-07

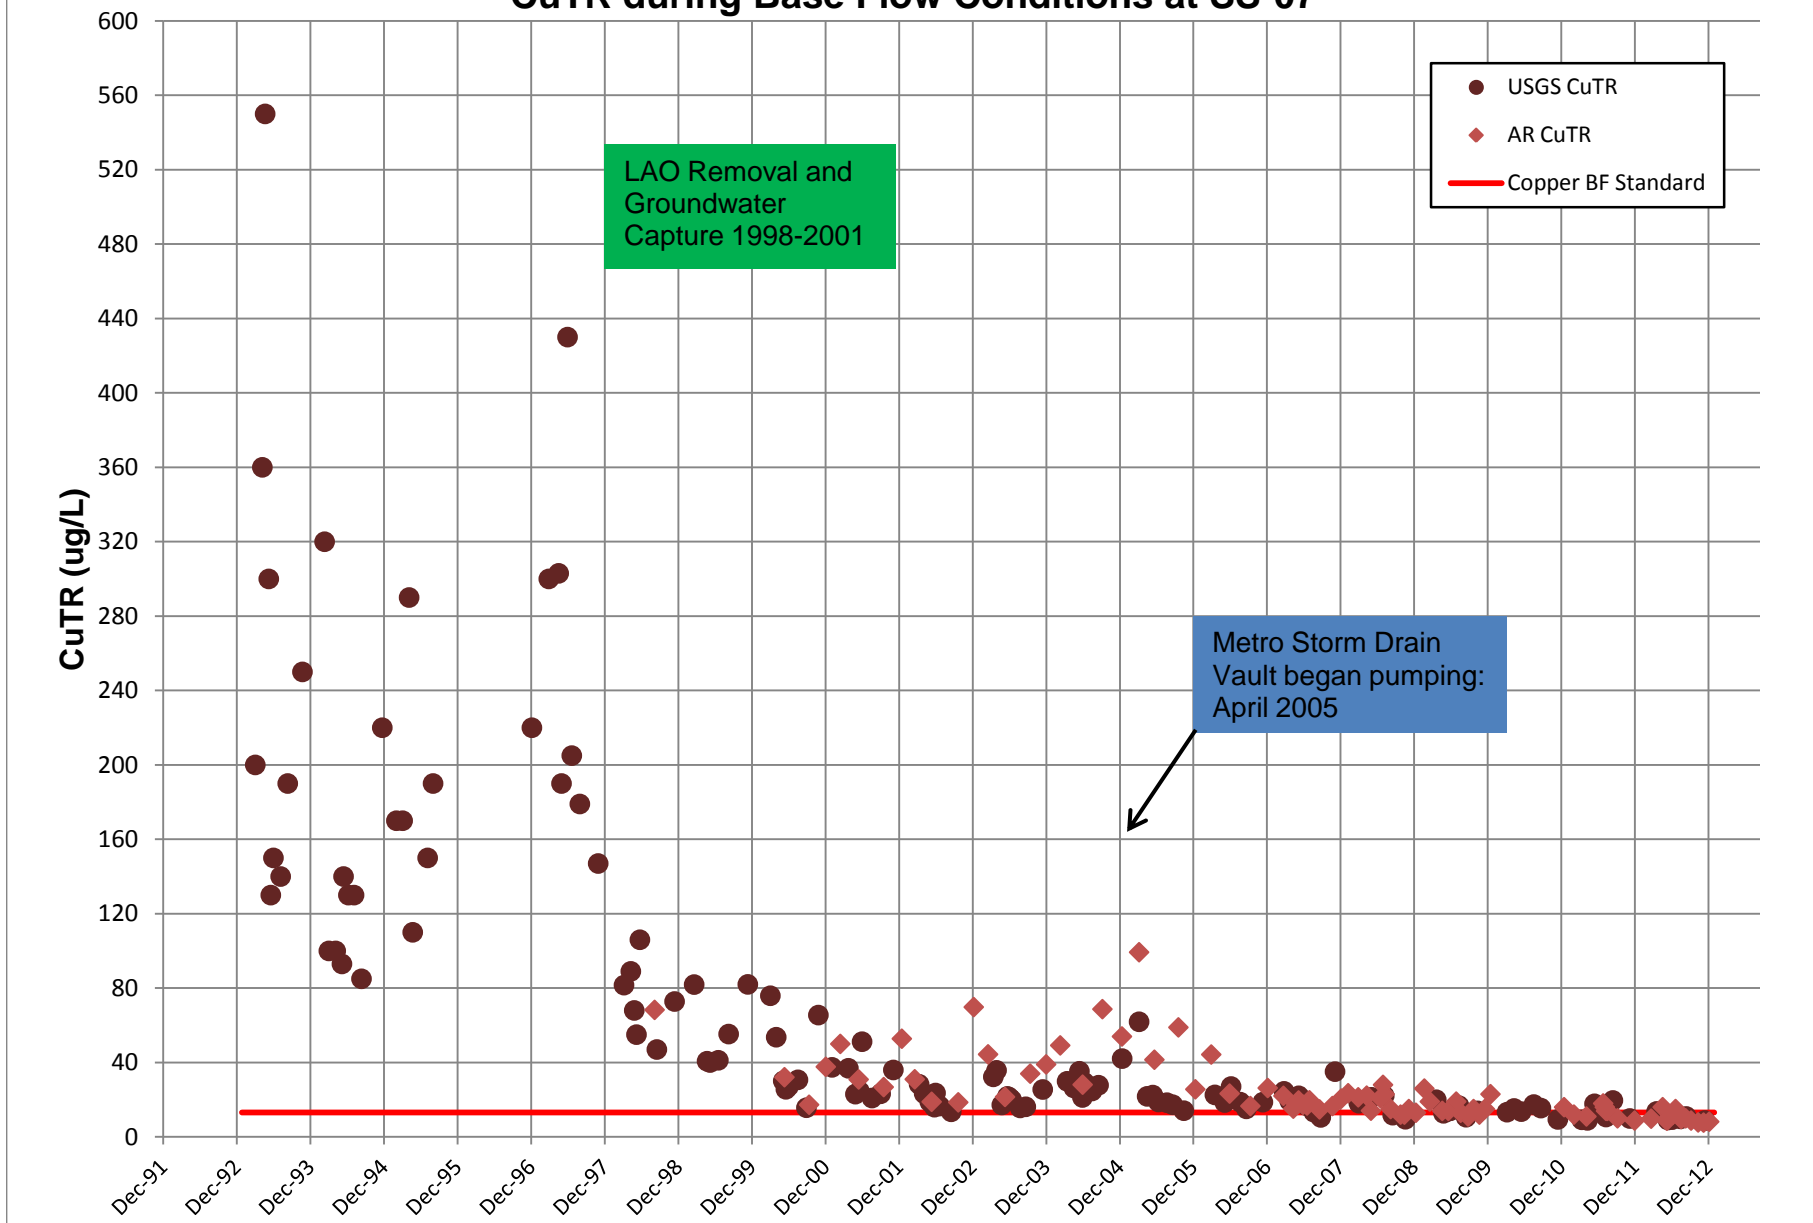
Surface Water Improvement in Silver Bow Creek CuTR during Base Flow Conditions at SS-07

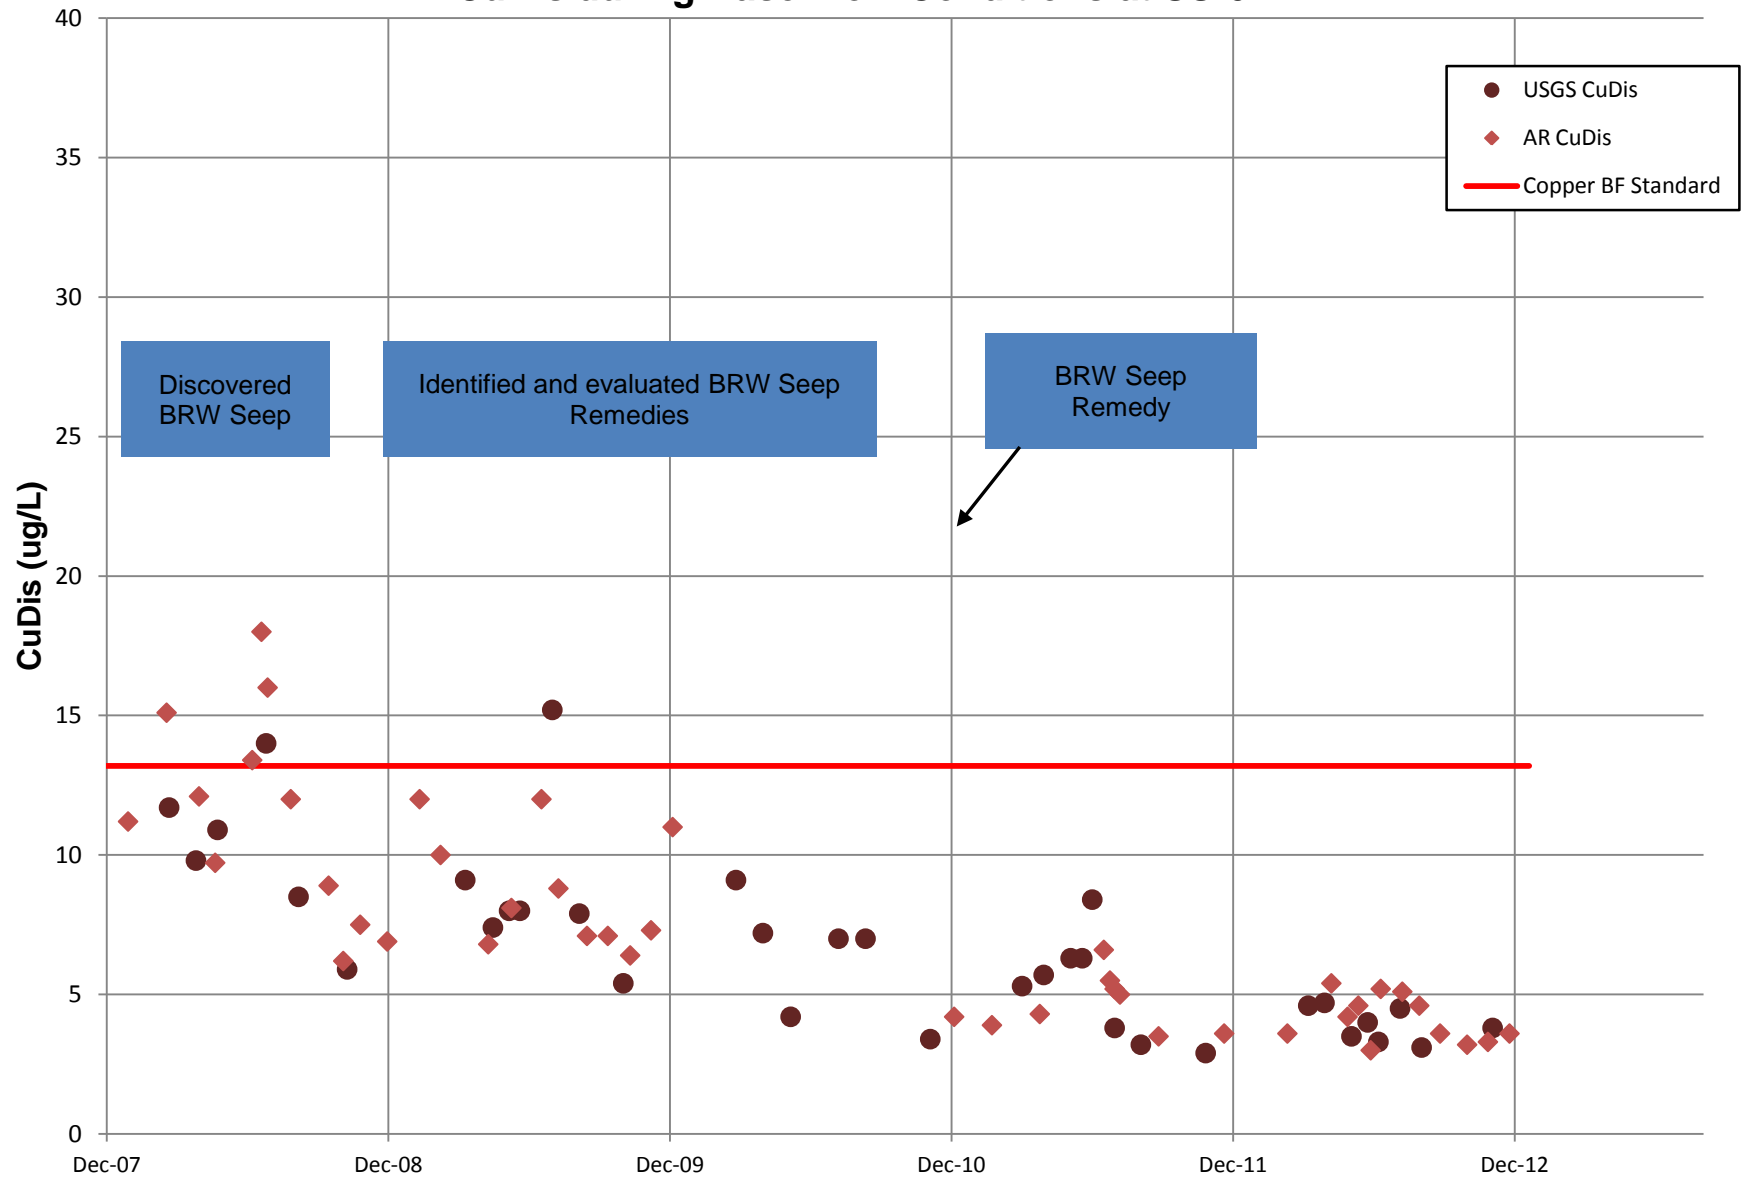
Surface Water Improvement in Silver Bow Creek CuDis during Base Flow Conditions at SS-07

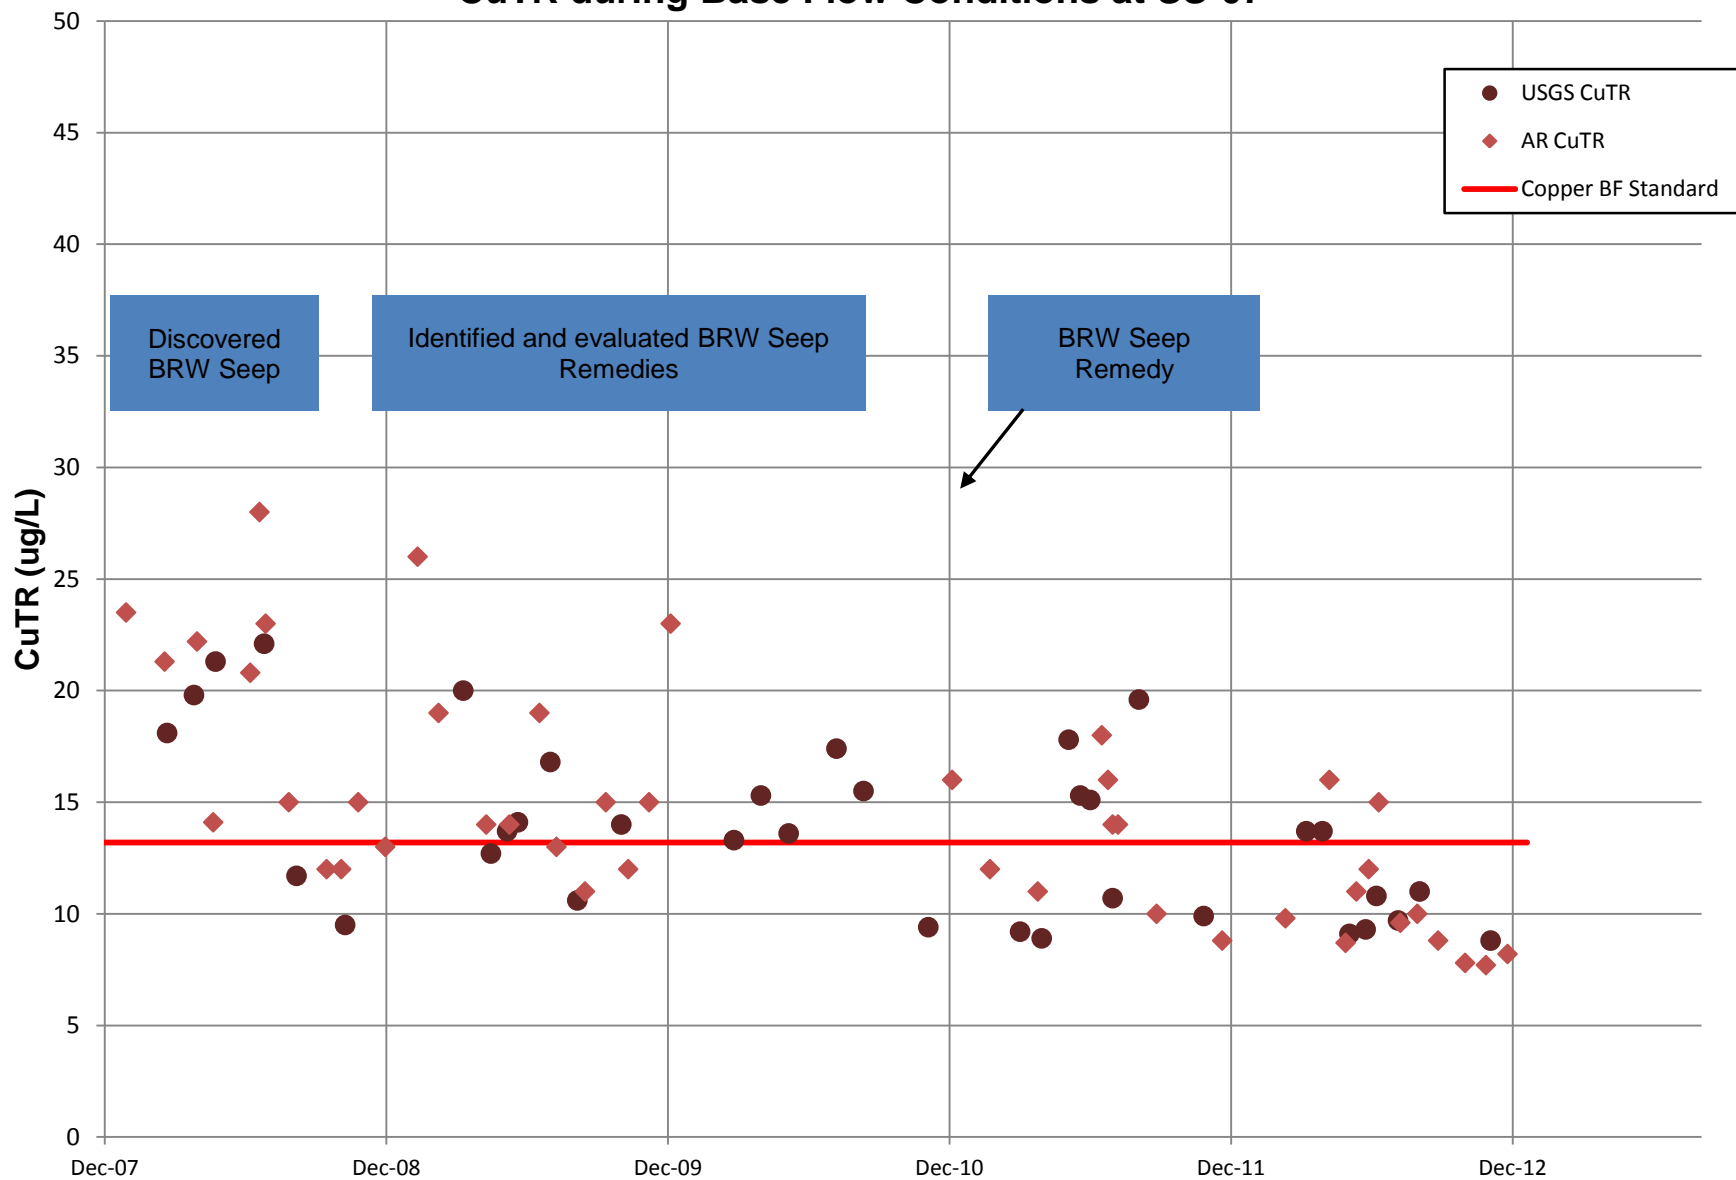
Surface Water Improvement in Silver Bow Creek CuTR during Base Flow Conditions at SS-07

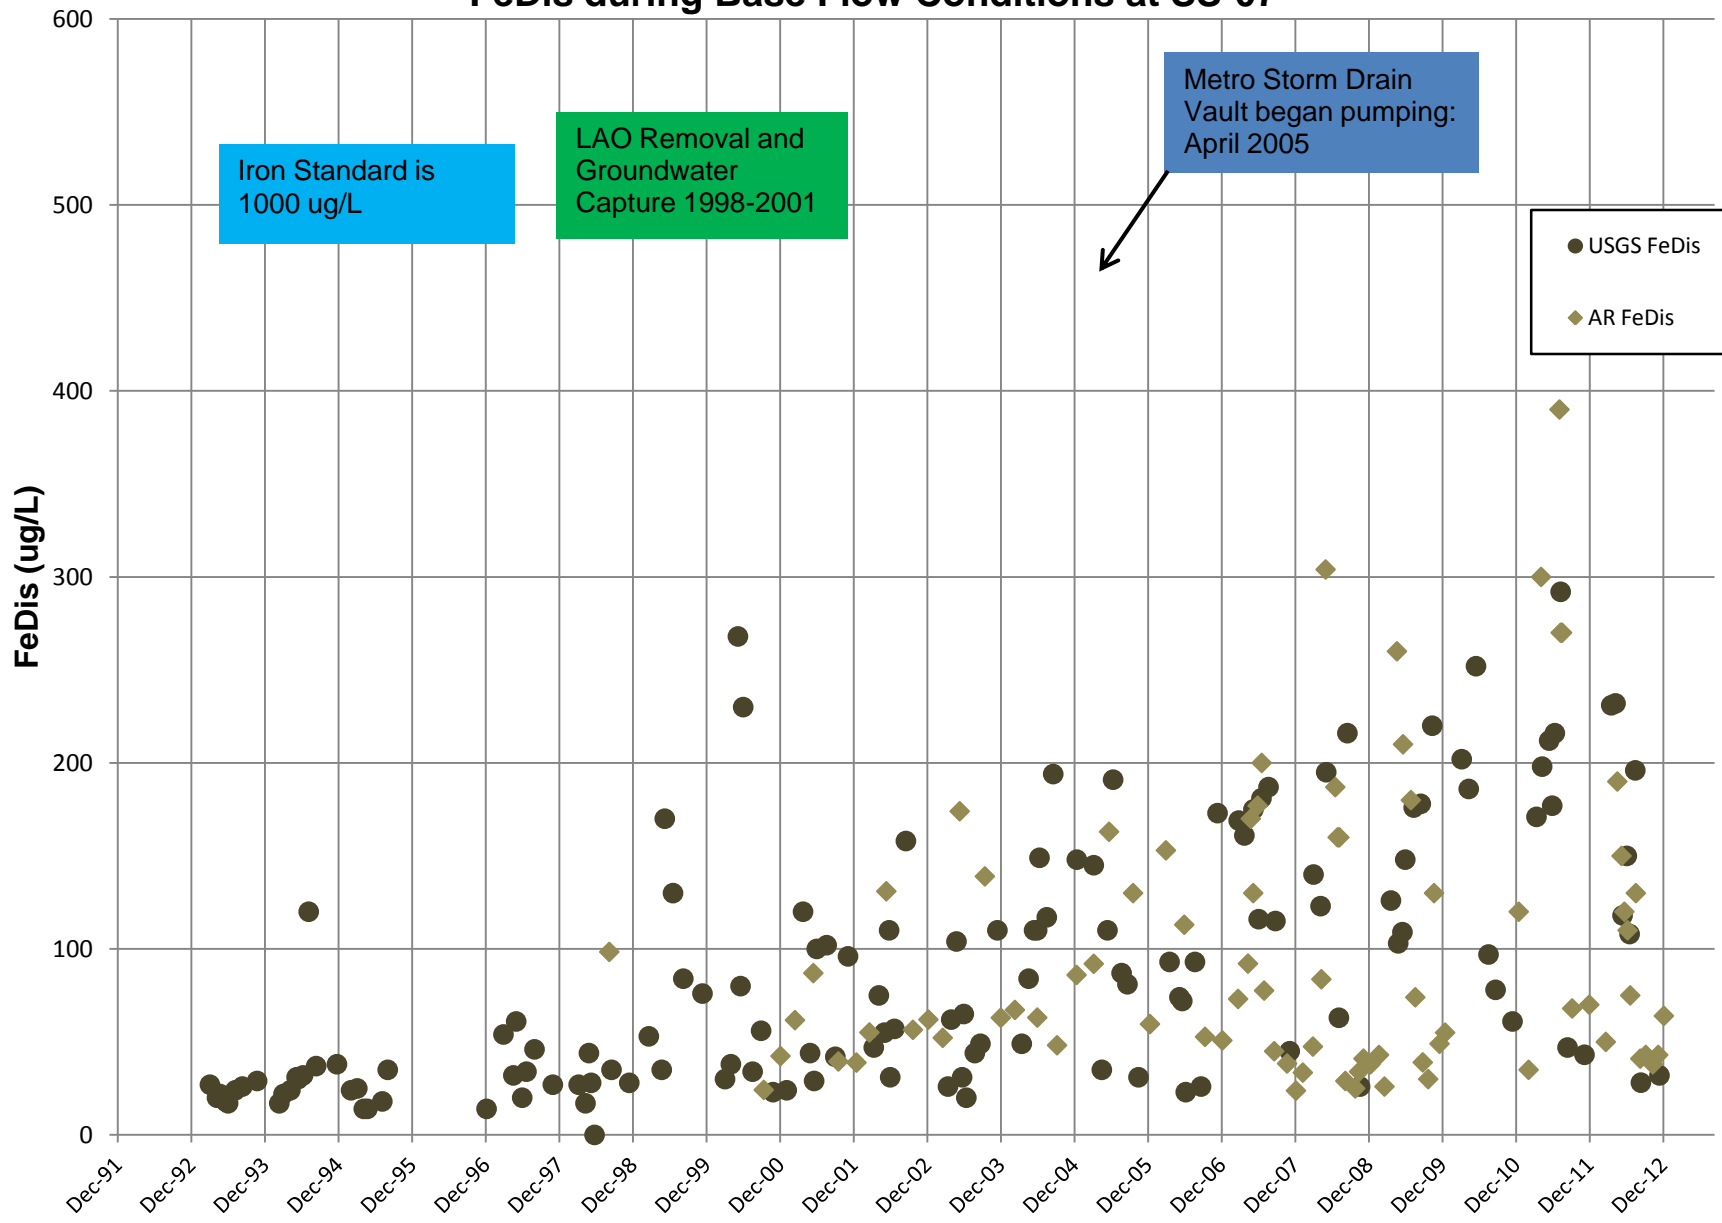
Surface Water Improvement in Silver Bow Creek FeDis during Base Flow Conditions at SS-07

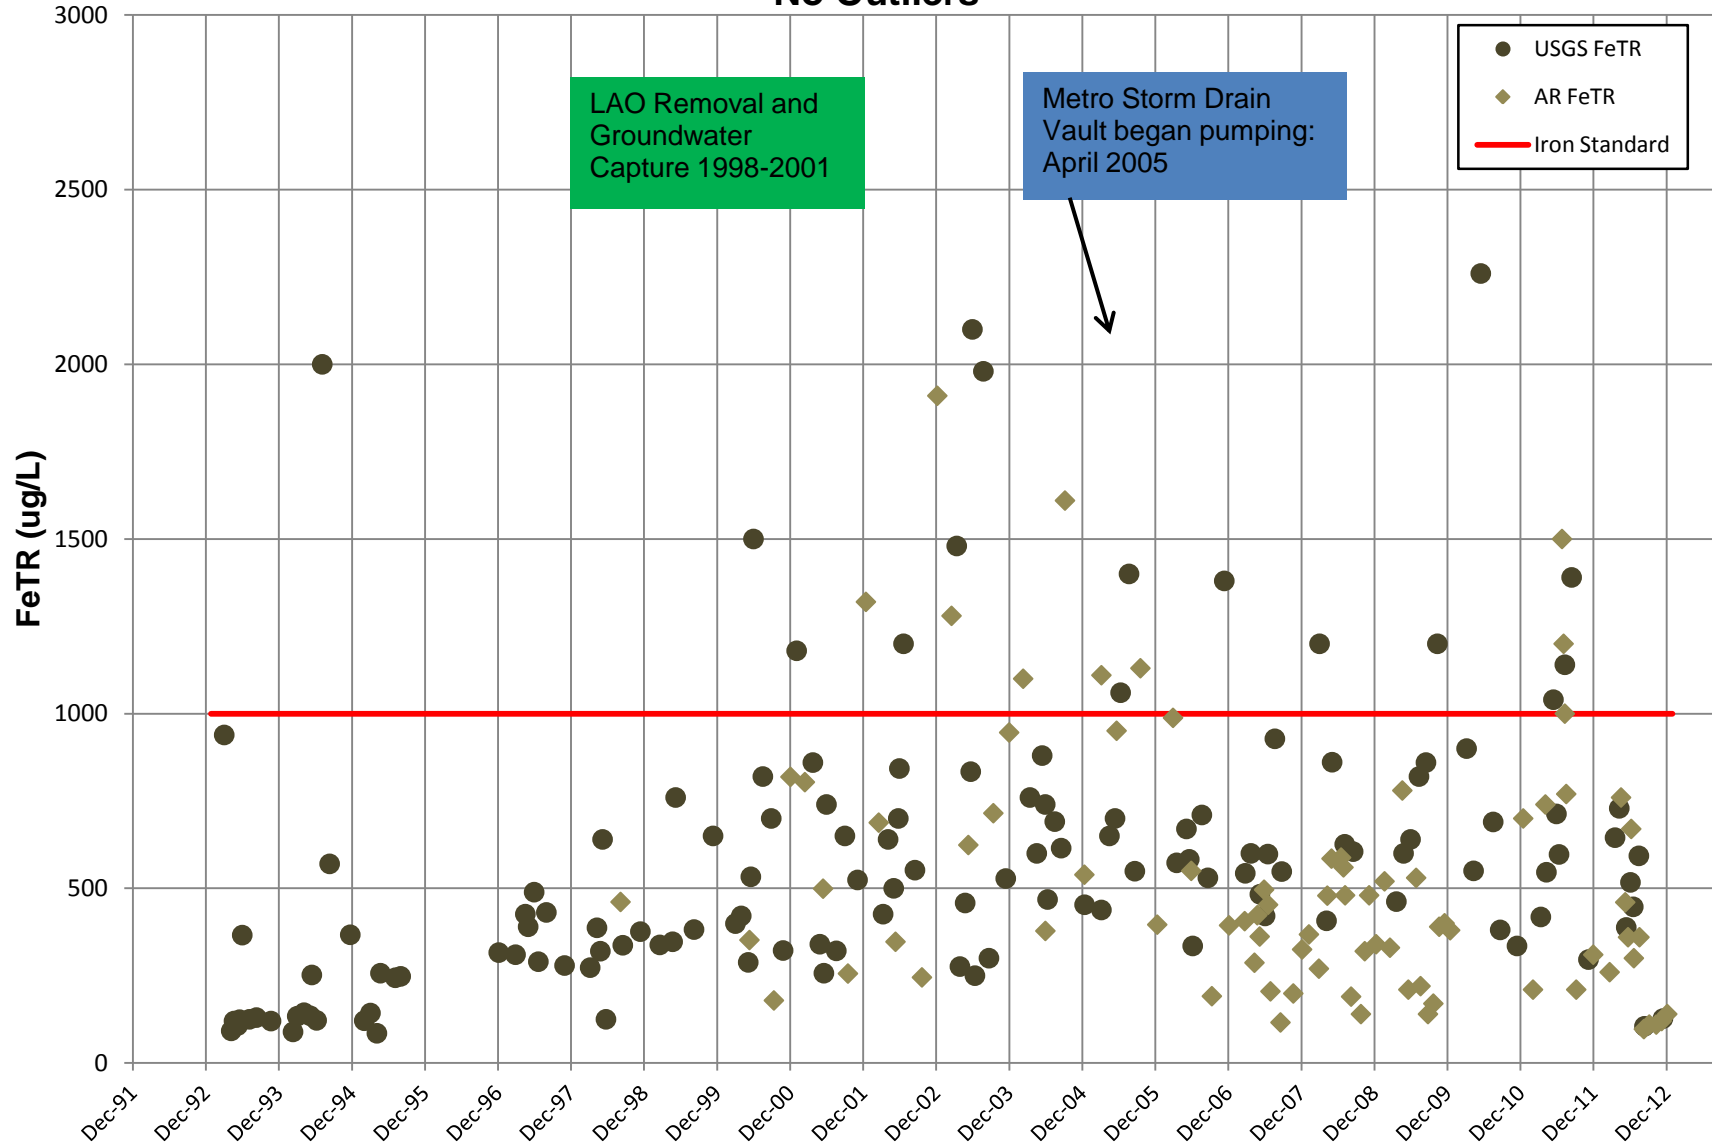
Surface Water Improvement in Silver Bow Creek FeTR during Base Flow Conditions at SS-07 No Outliers

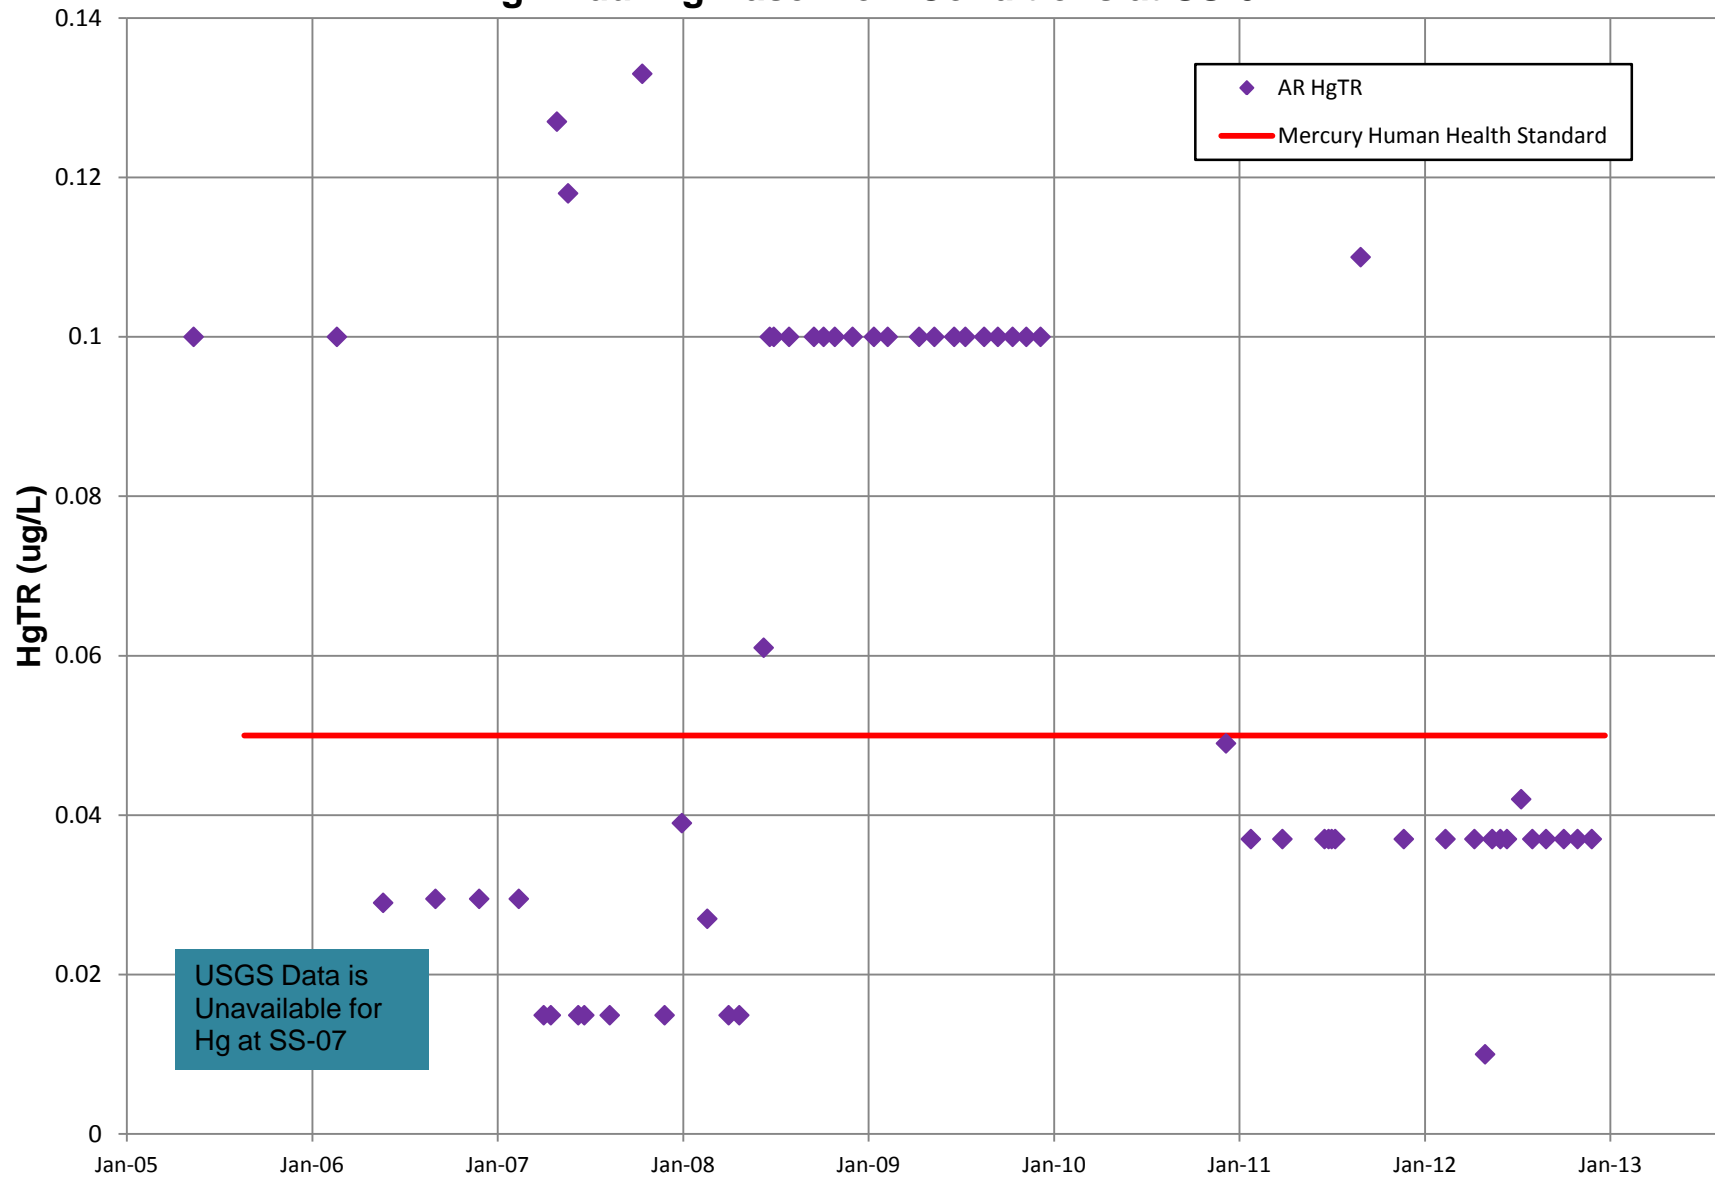
Surface Water Improvement in Silver Bow Creek HgTR during Base Flow Conditions at SS-07

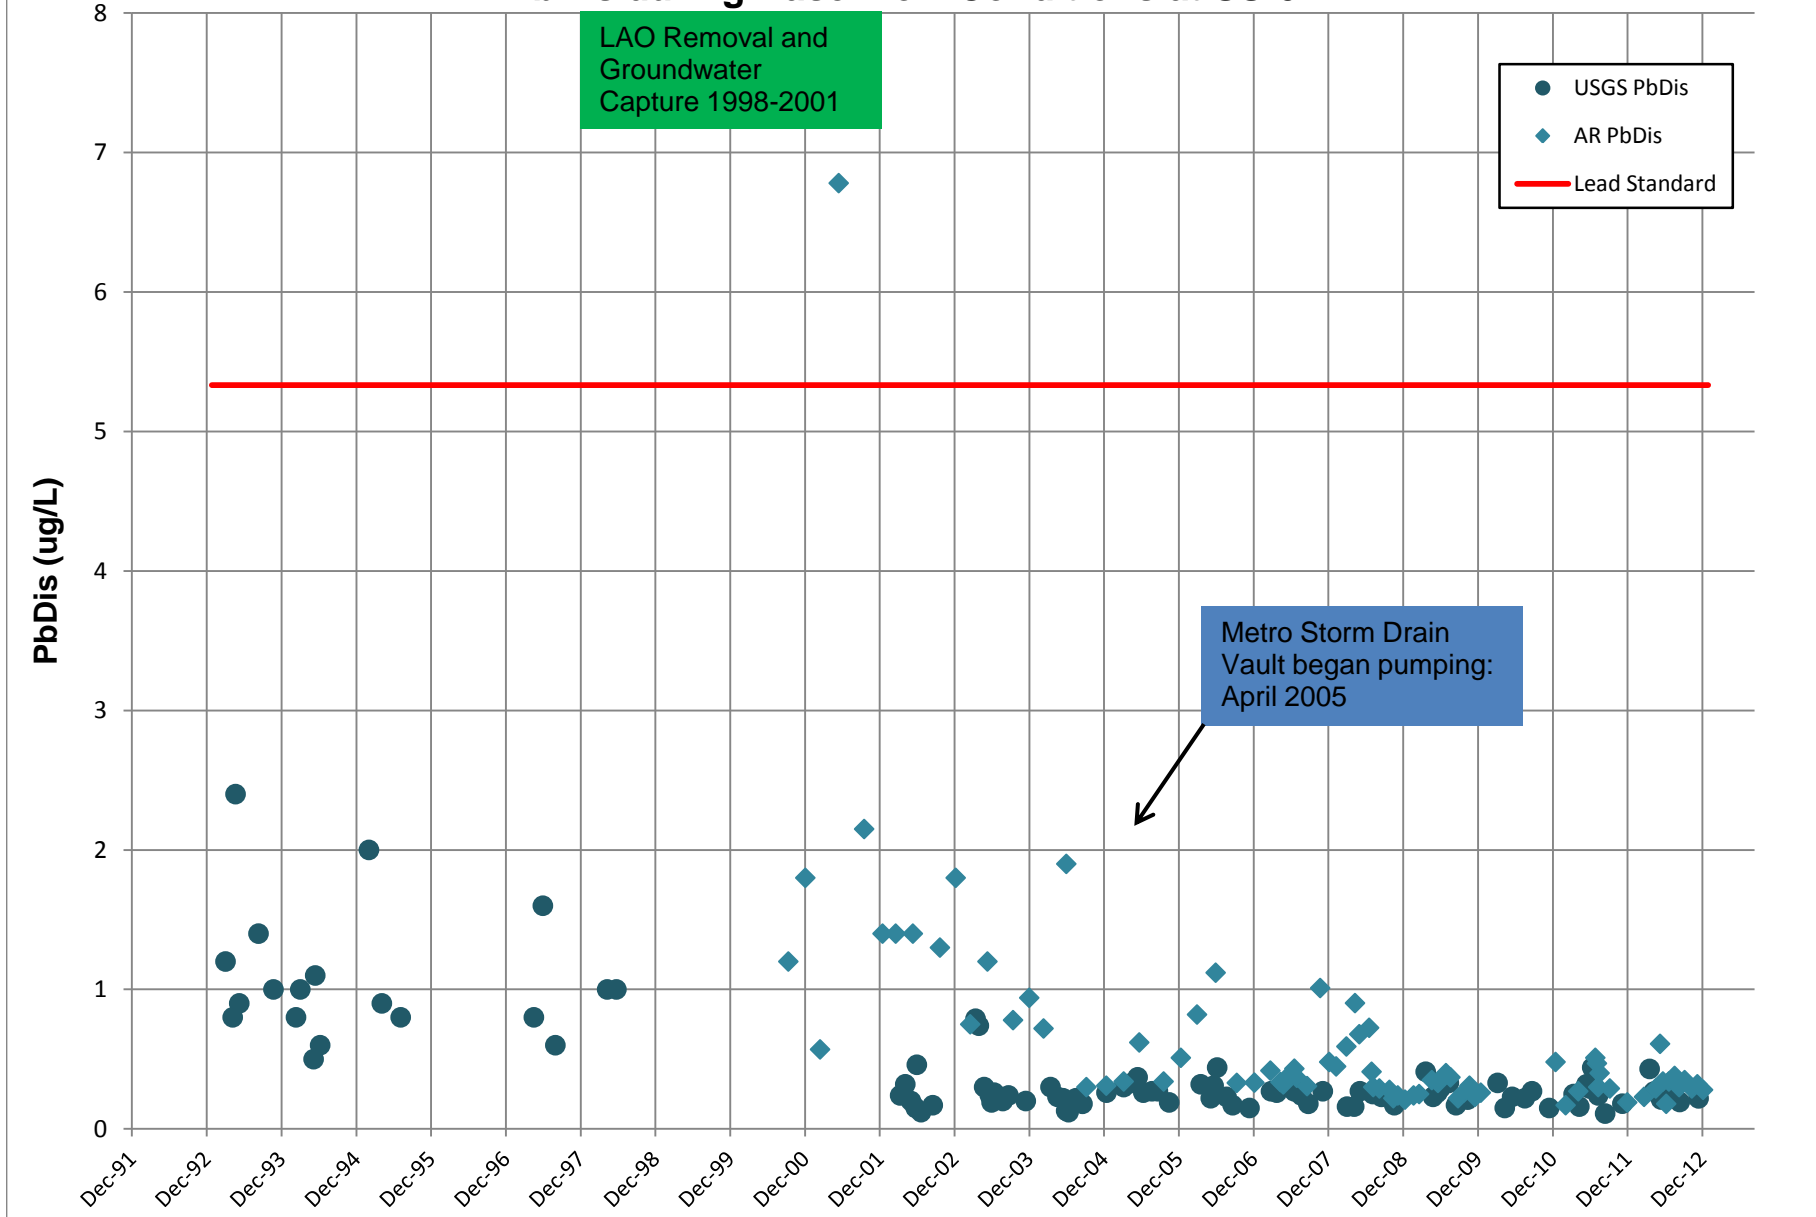
Surface Water Improvement in Silver Bow Creek PbDis during Base Flow Conditions at SS-07

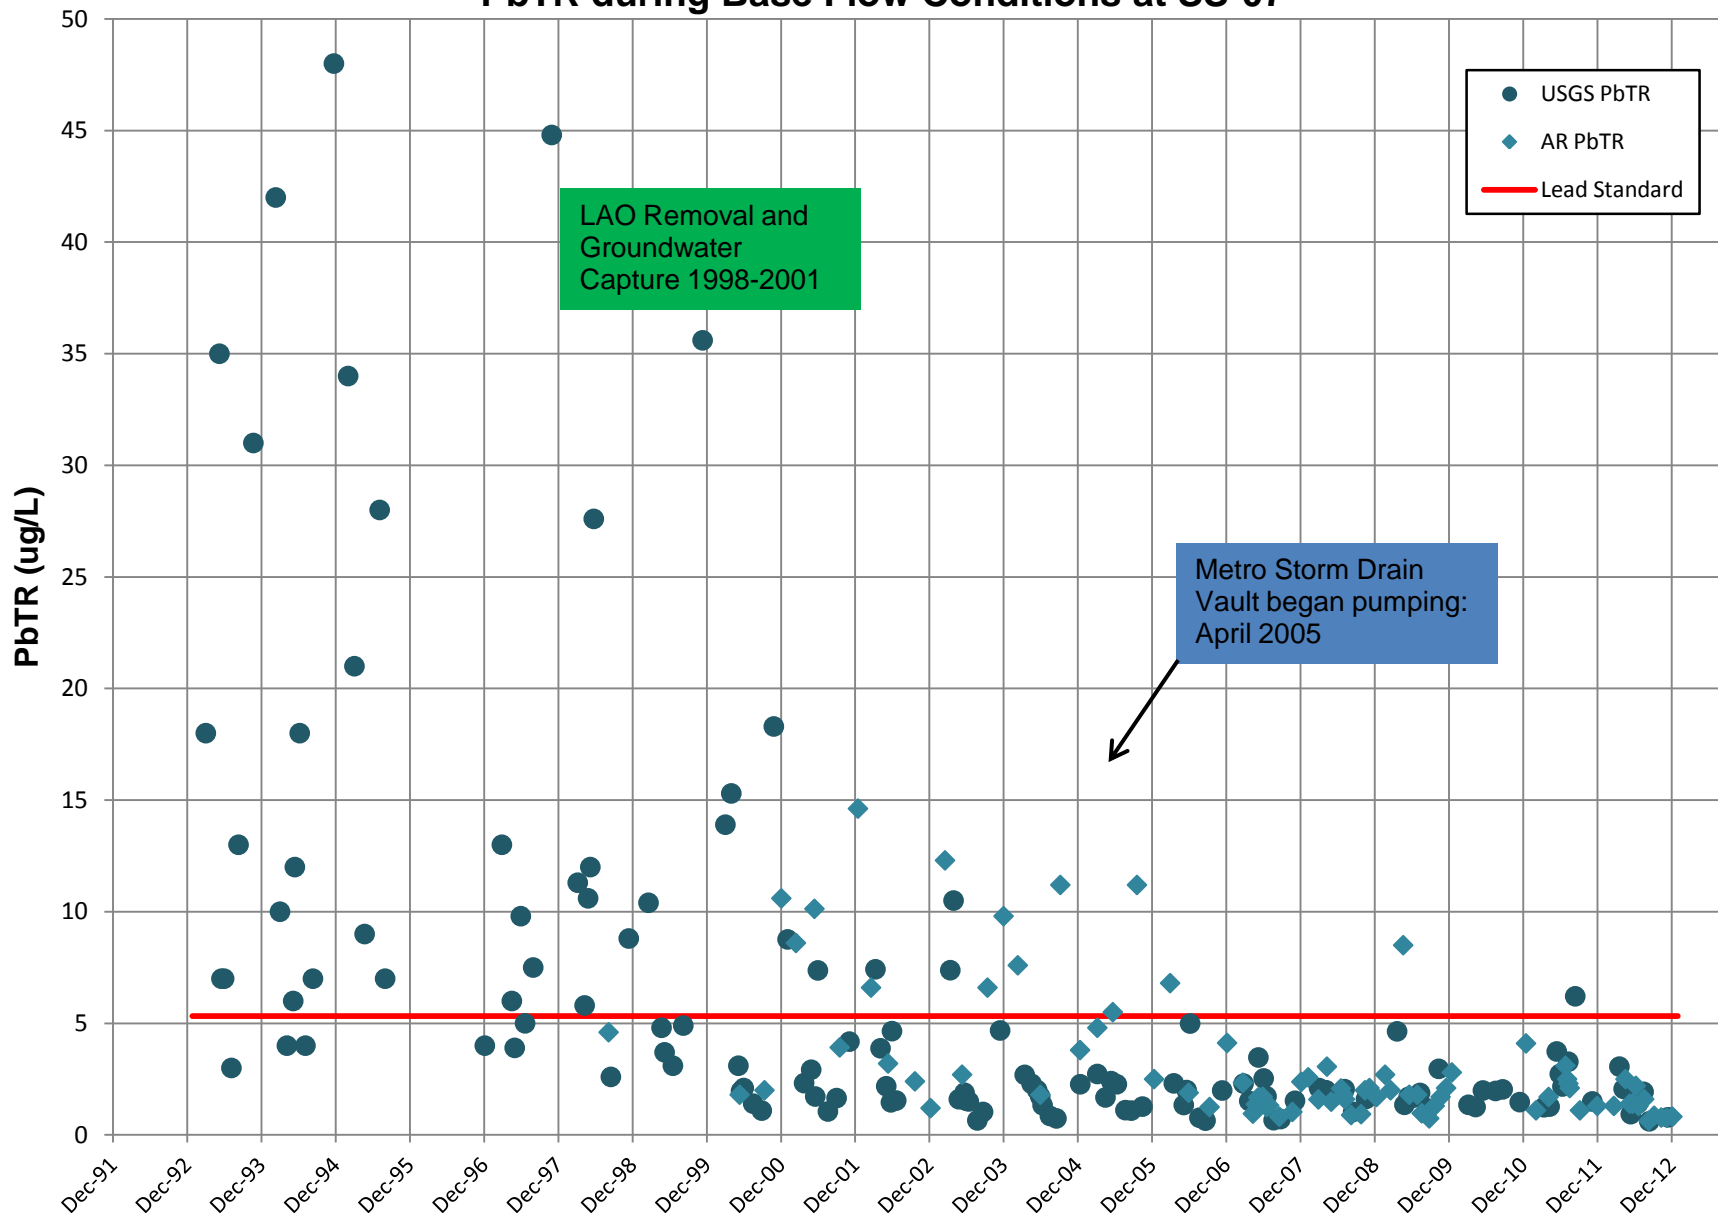
Surface Water Improvement in Silver Bow Creek PbTR during Base Flow Conditions at SS-07
