Surface Water Improvement in Silver Bow Creek AsDis during Base Flow Conditions at SS-07

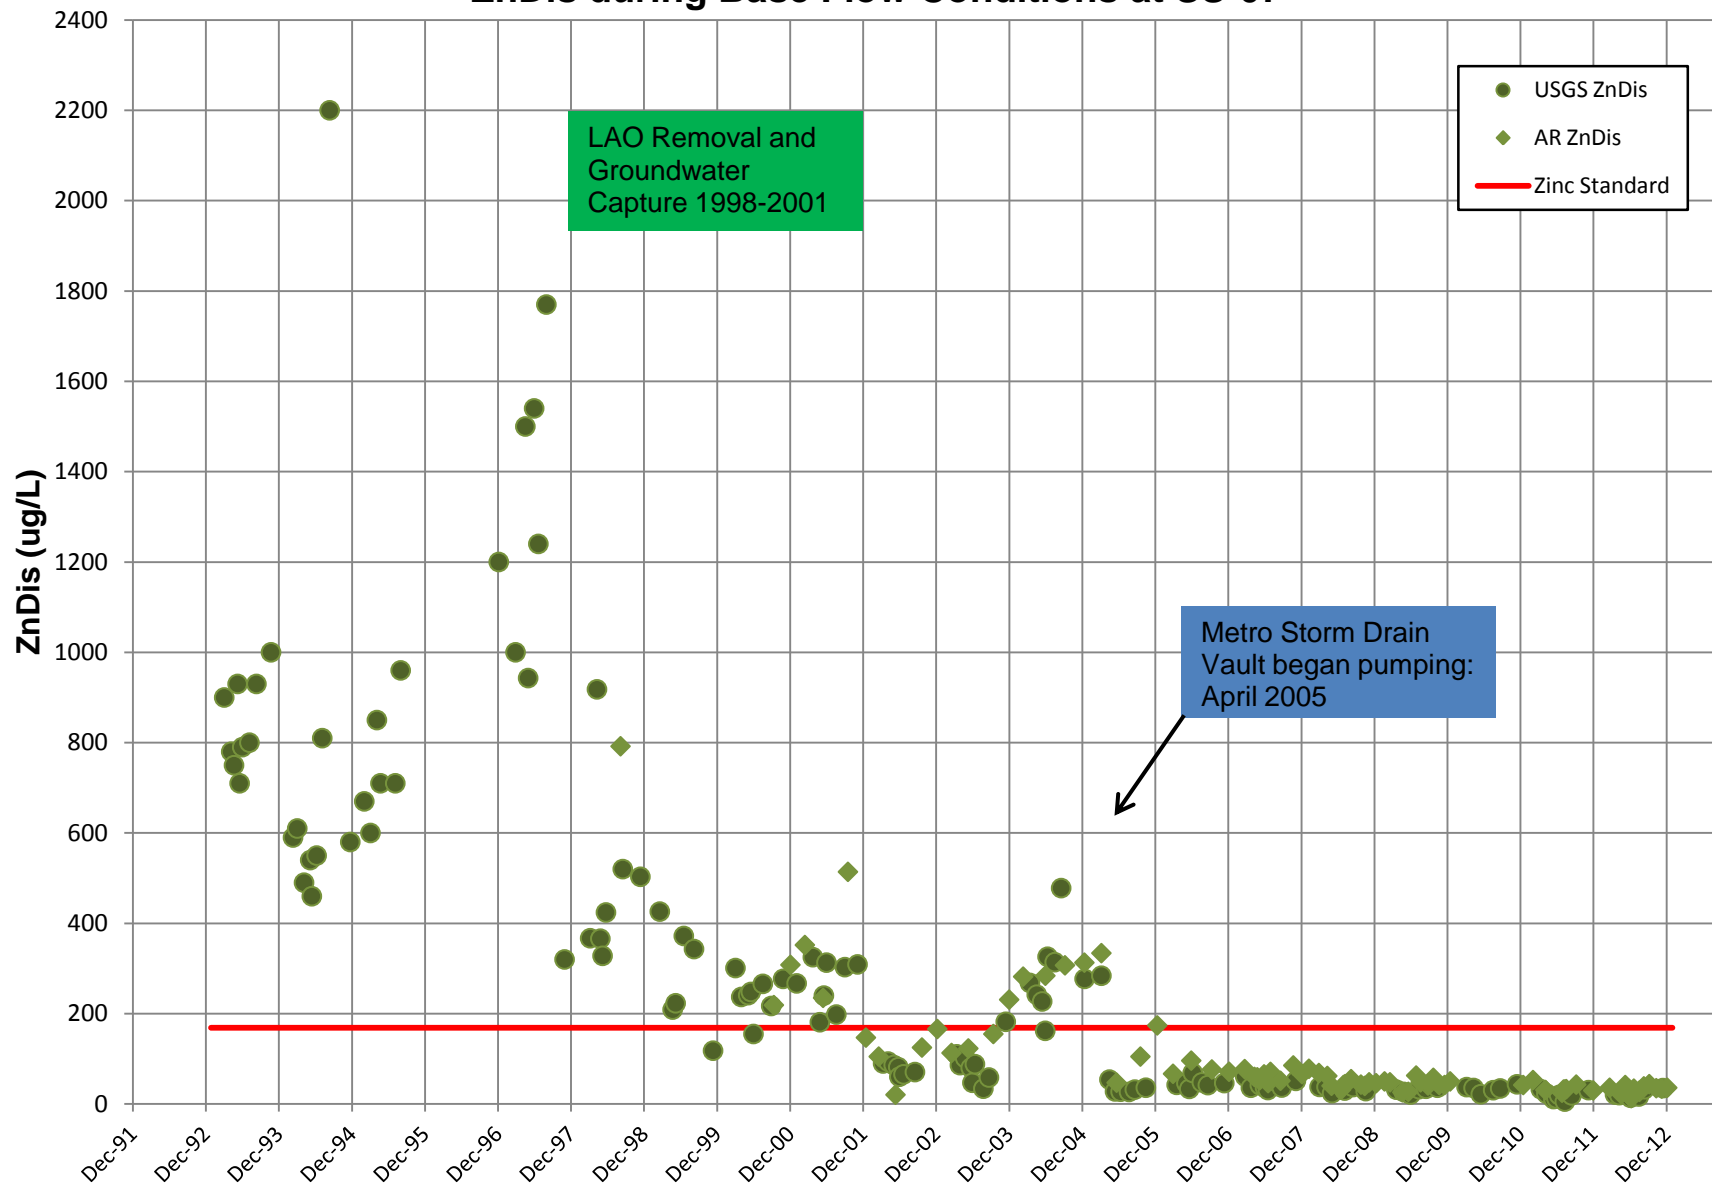
Surface Water Improvement in Silver Bow Creek ZnDis during Base Flow Conditions at SS-07

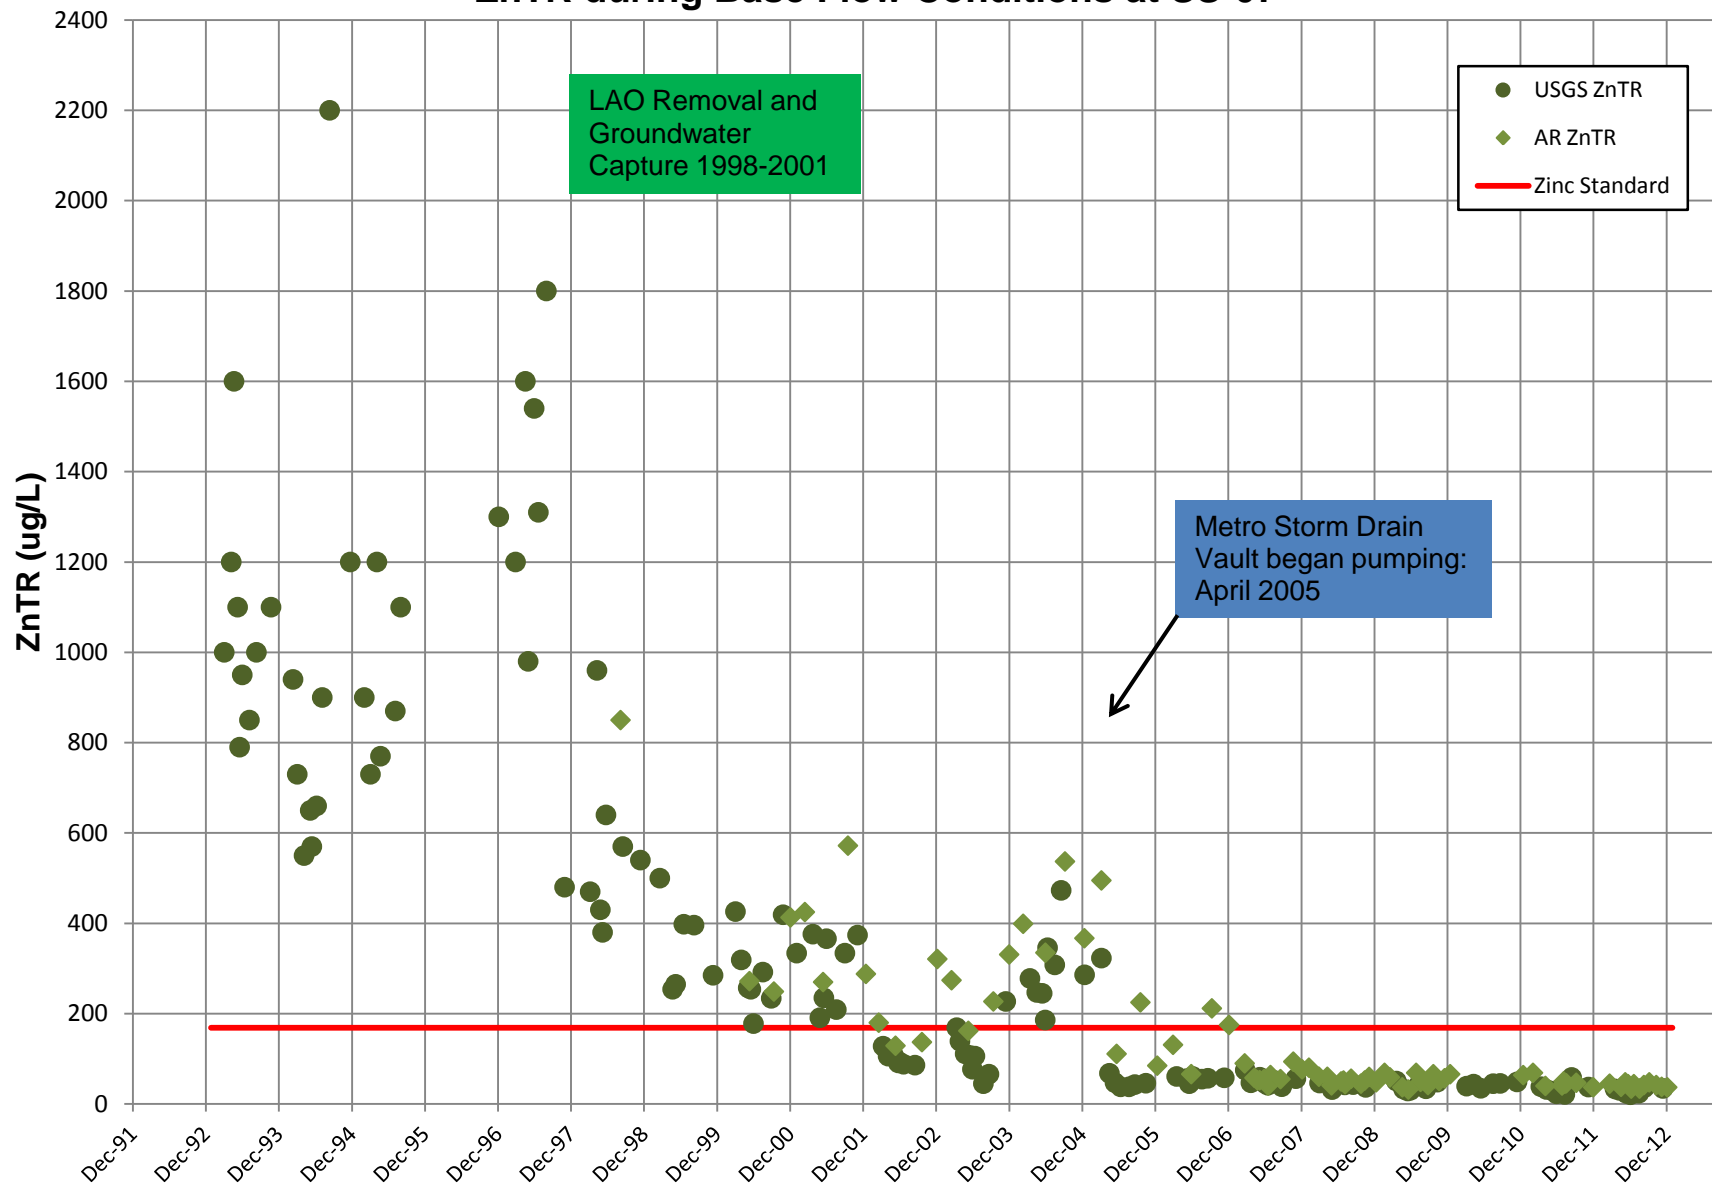
Surface Water Improvement in Silver Bow Creek ZnTR during Base Flow Conditions at SS-07
